AAPM&R 2017 Annual Assembly and Technical Exhibition

Cursory ADA Facility Survey Report

May 11 and 12, 2016

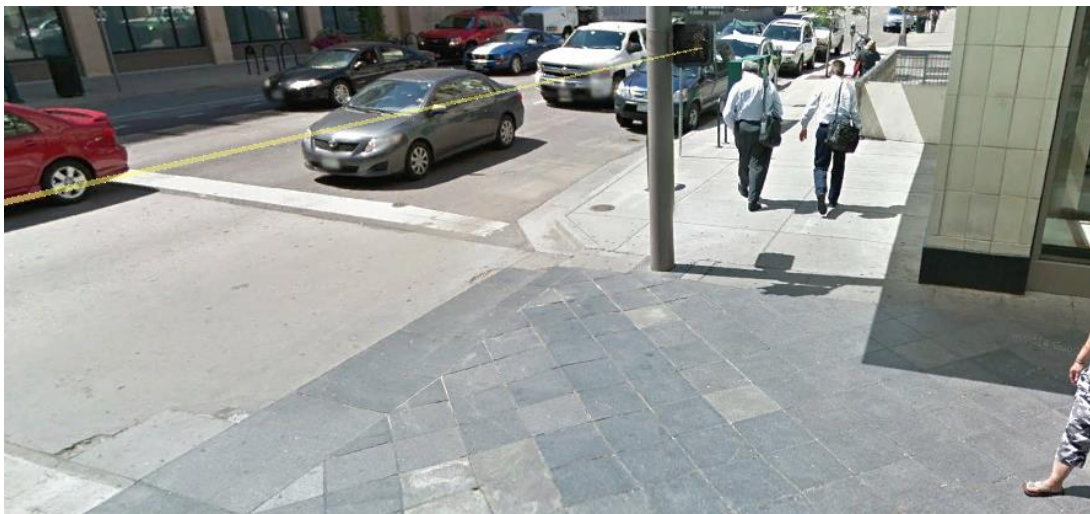
- The accessible route to the Pinnacle Club at the Grand Hyatt crosses the 16th Street Mall. The blended curb ramps do not have tactile warning strips or delineated crosswalks and the mall

shuttle buses cross at these intersections. Compliant curb ramps should be placed as maintenance occurs in these locations.

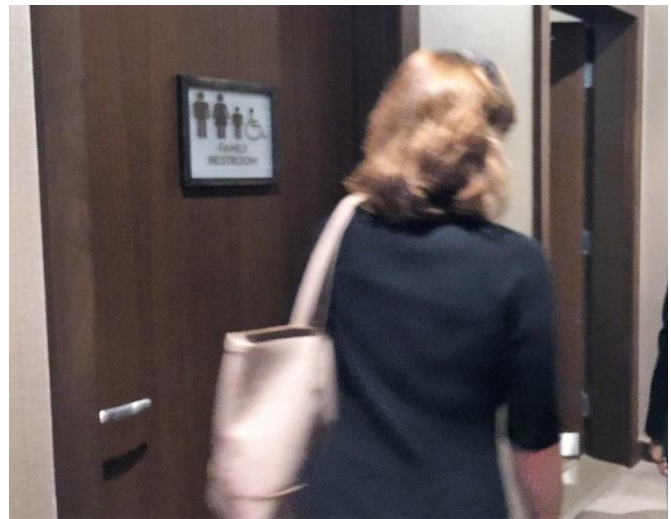
- The drinking fountains are hidden around a corner at the end of the restroom hall. Add directional signage.

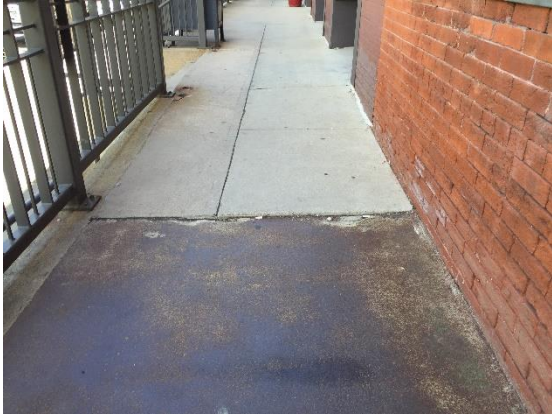
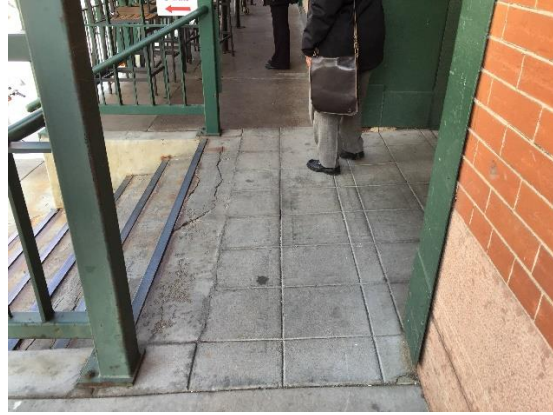
- The accessible route has several joints that have changes in level greater than $\frac{1}{4}$ " vertical or $\frac{1}{2}$ " maximum beveled. Recommend repairing these sections of pavement.

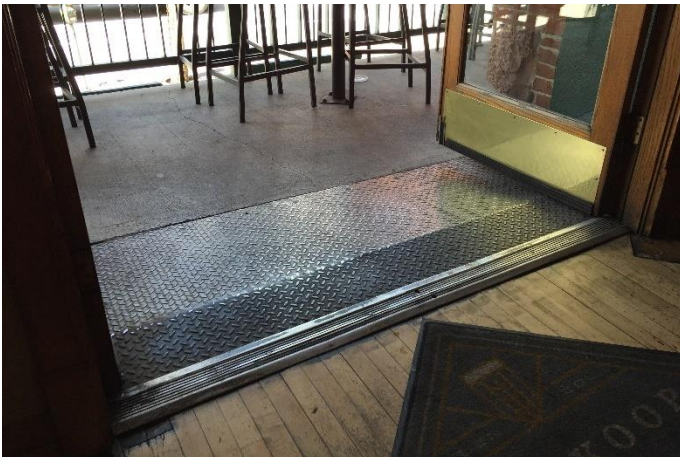
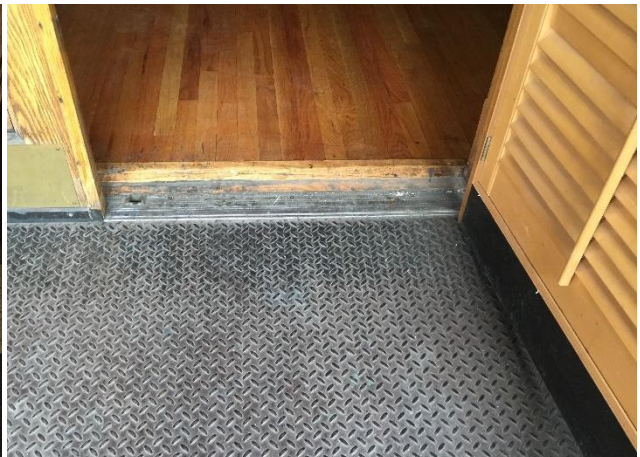
- The threshold at the accessible entrances are too high, need to be $\frac{3}{4}$ " high maximum with beveled edges. Recommend replacing with $\frac{1}{2}$ " high maximum thresholds.

404.2.5 Thresholds. Thresholds, if provided at doorways, shall be $\frac{1}{2}$ inch (13 mm) high maximum. Raised thresholds and changes in level at doorways shall comply with 302 and 303.

EXCEPTION: Existing or altered thresholds $\frac{3}{4}$ inch (19 mm) high maximum that have a beveled edge on each side with a slope not steeper than 1:2 shall not be required to comply with 404.2.5.

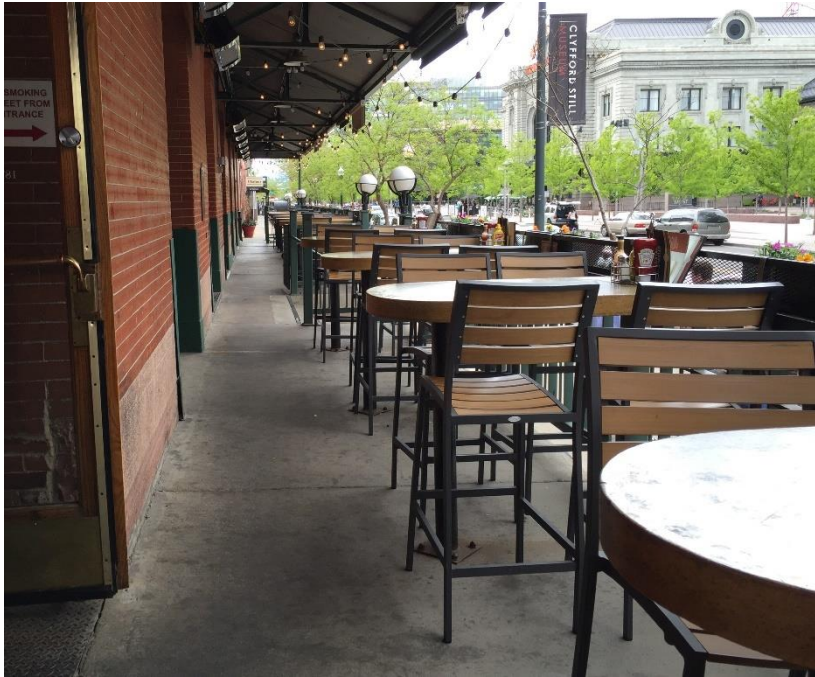
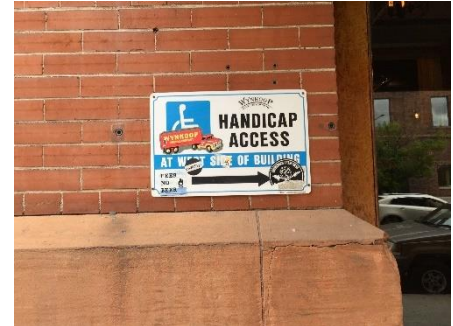
- The directional sign at the front entrance needs to be replaced, change wording to accessible entrance instead of handicap access.

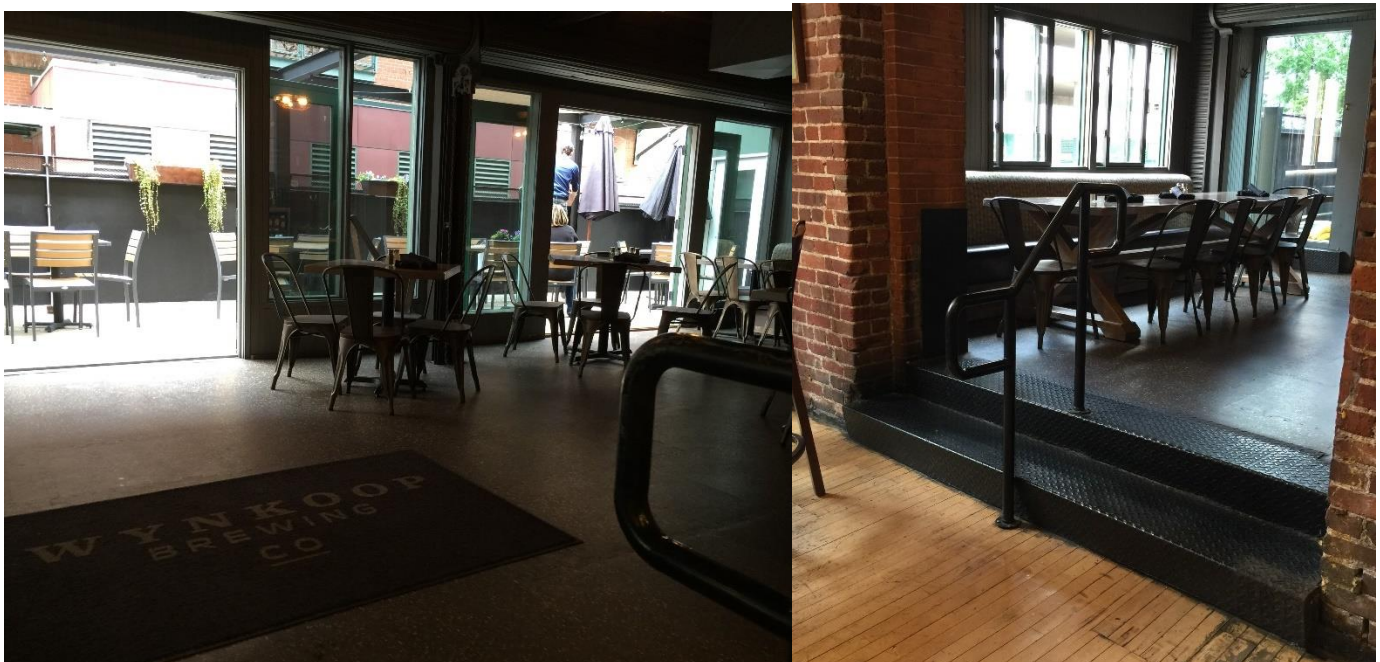
- Neither of the exterior eating areas are accessible to wheelchair users. Recommend adding accessible seating when any modifications are made to one of these areas to meet the requirement for access.

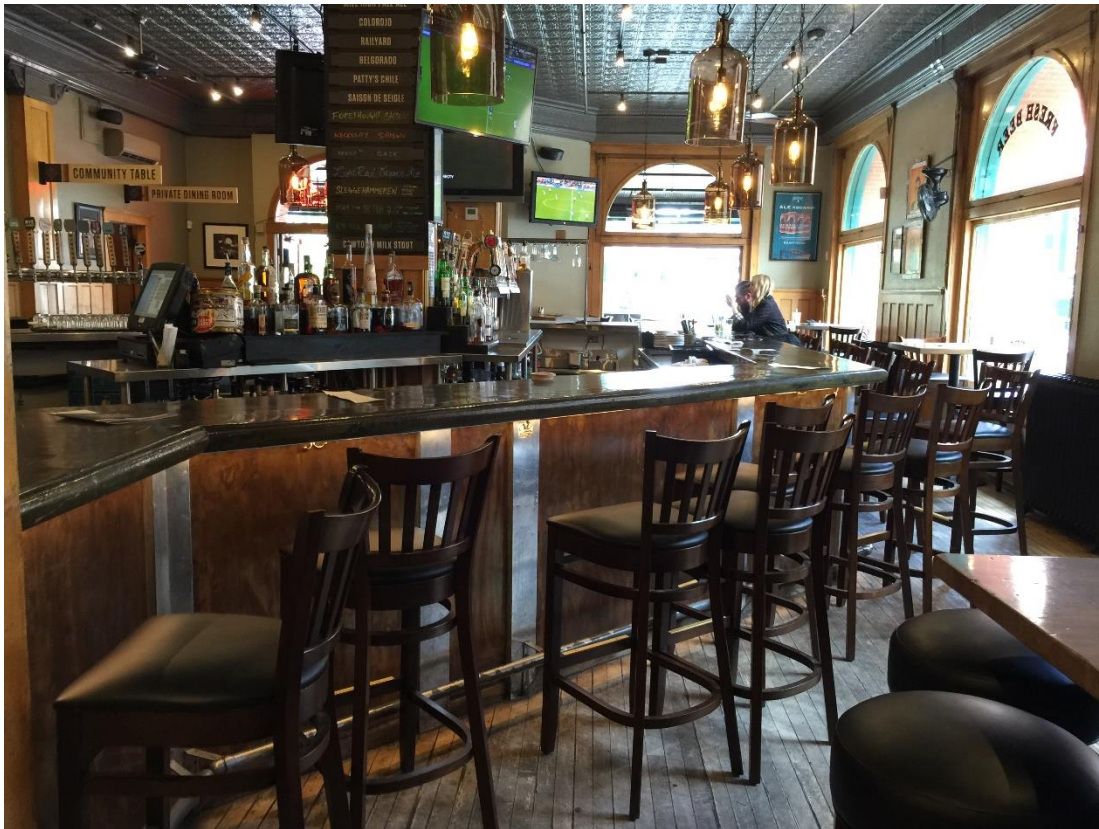
- There are several bars in the facility, none have a lowered section for accessible seating. Sitting at the bar is a unique experience from table service and should be made accessible so that all patrons have this available to them. Recommend adding a lowered section at one or more of the bars.

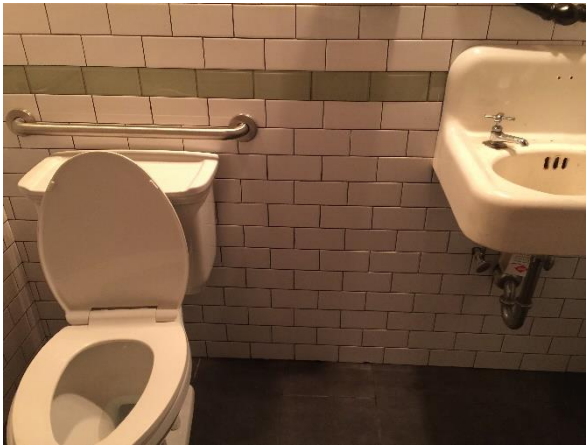
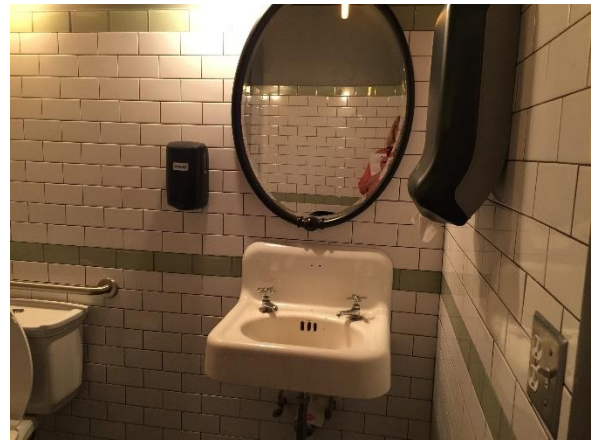
- The first floor accessible restroom does not meet accessibility requirements:
 - Required clear floor space at door is blocked by a chair and movable trash can. Remove chair from room and replace trash can with narrow version on the door side of sink.
 - Watch video link to understand all accessibility requirements needed in accessible restrooms, make sure cleaning and maintenance staff understand their role in maintaining access.

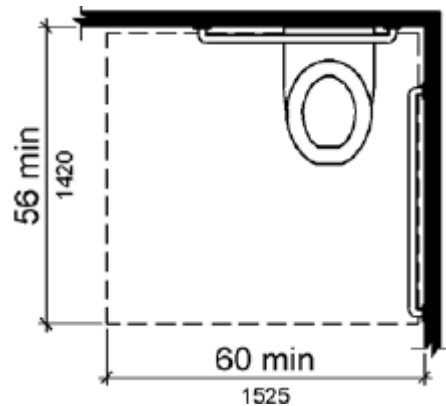
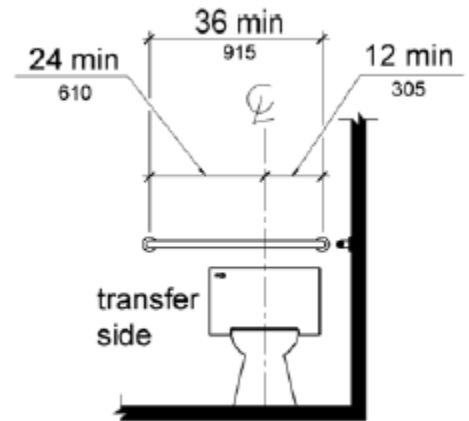
- There needs to be adequate clear space adjacent to the toilet for a side transfer. The new lavatory to be installed in this room should be moved closer to the side wall to provide the 60" required. Install a 36" grab bar along rear wall in place of the 24" existing.

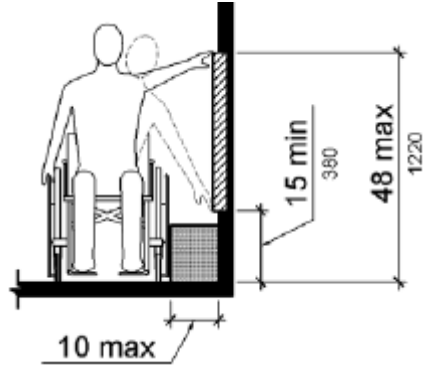
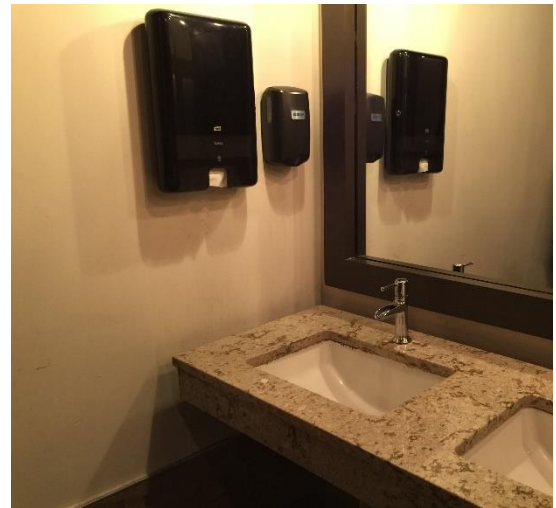
- Second floor restrooms have most required accessibility features, elements that need to be addressed:
 - Entrances have very high thresholds. Replace with ½" beveled maximum.
 - Both restrooms have 6 or more fixtures, they need a wheelchair accessible compartment (provided) and an ambulatory compartment (not provided). Modify one stall in each restroom to be an ambulatory stall that opens outward with handles on both sides of door.

- Soap and towel dispensers need to be lowered to 48" max. from floor to outlet.

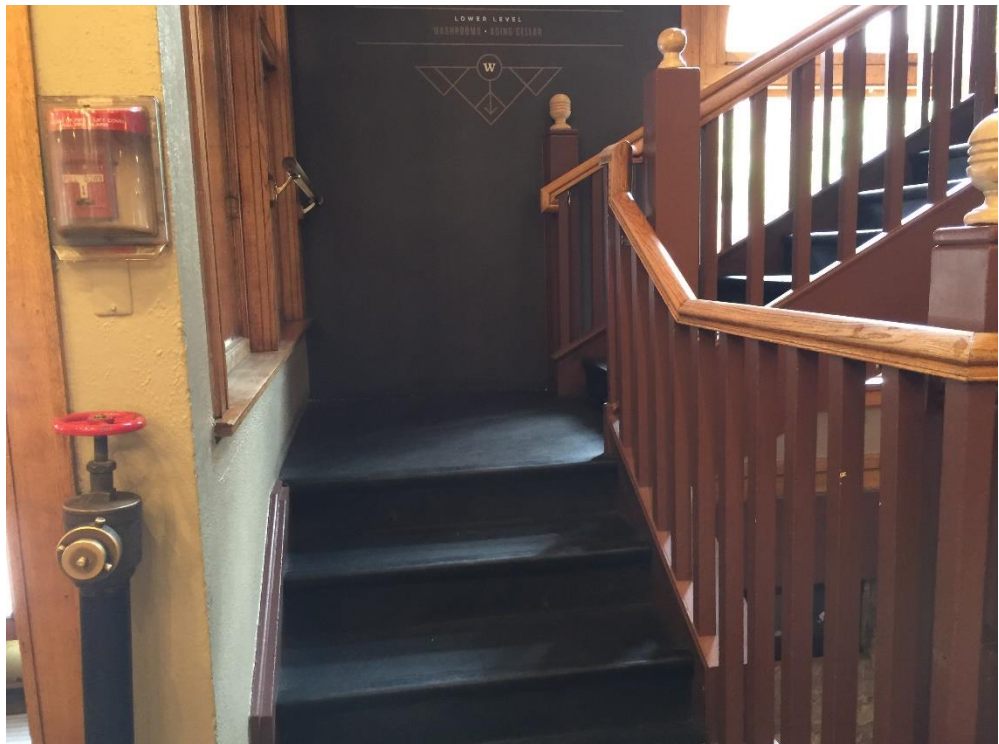
- Handrails do not meet building code or accessibility requirements for historic buildings. These are the main egress stairs for the building and should meet requirements. Recommend adding compliant handrails adjacent to the historic rails. Provide handrails on both sides of stairs.

505.6 Gripping Surface. Handrail gripping surfaces shall be continuous along their length and shall not be obstructed along their tops or sides. The bottoms of handrail gripping surfaces shall not be obstructed for more than 20 percent of their length. Where provided, horizontal projections shall occur 1½ (38 mm) minimum below the bottom of the handrail gripping surface.

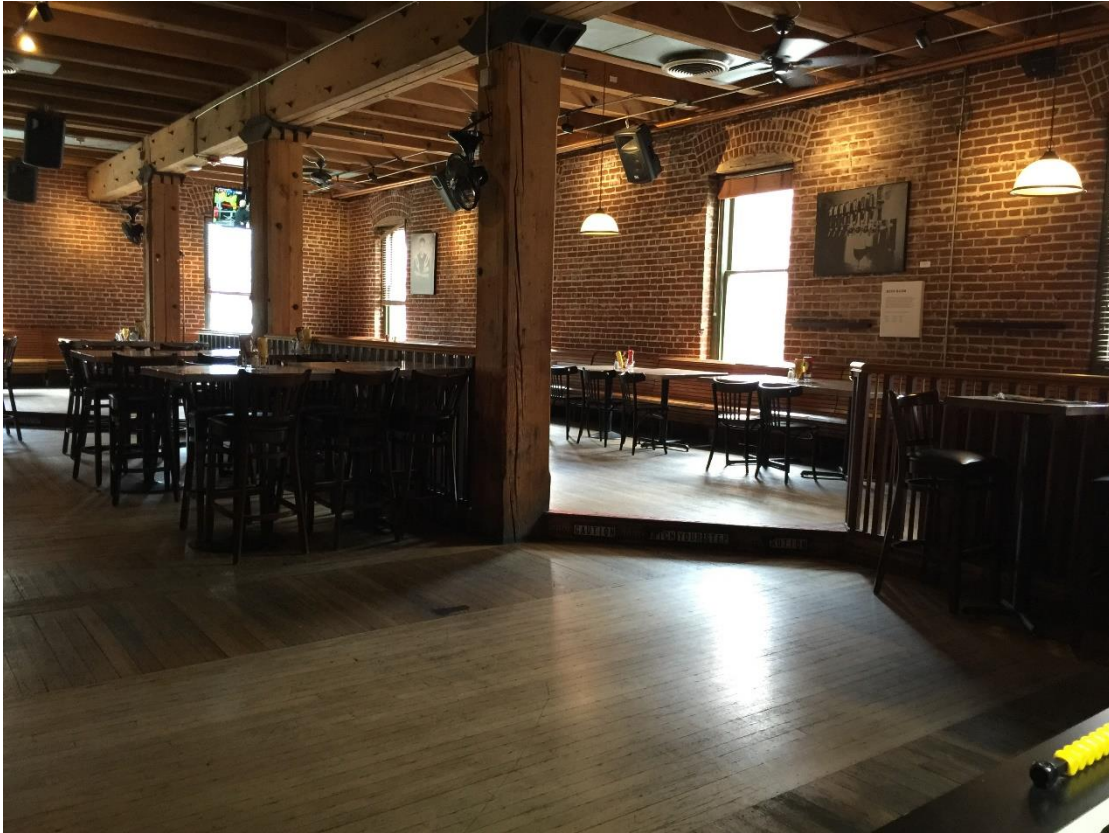
Most of the accessible height tables on the second floor are located up a 6” step. Provide accessible tables on the main level or ramp to make this upper area accessible.

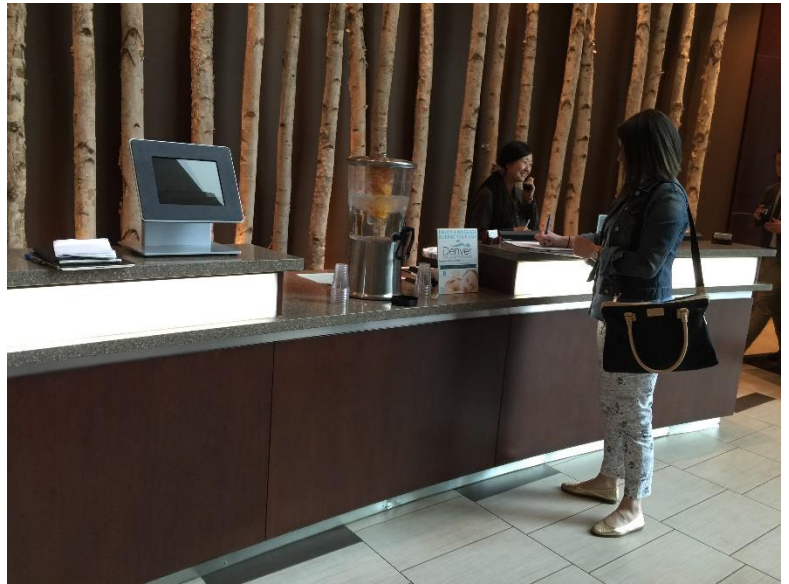
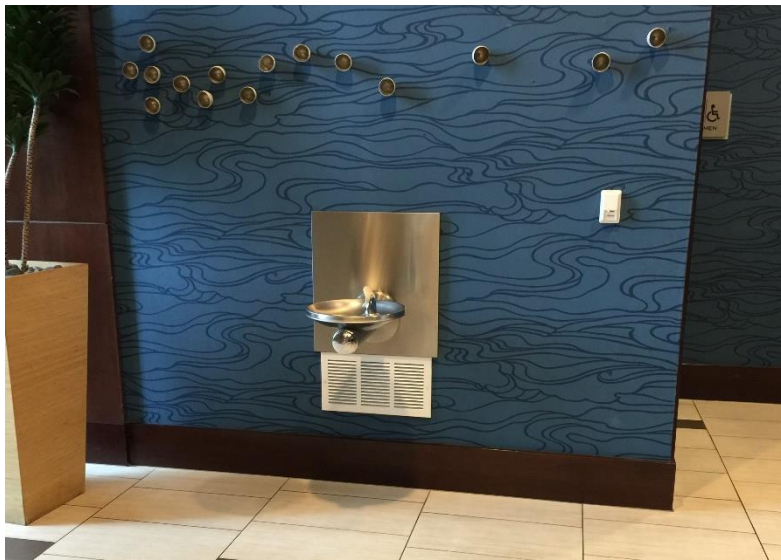
- The accessible section of the registration counter is being used for water service. Need to maintain a minimum of 36" clear counter length for a parallel approach by wheelchair users. Train staff to greet wheelchair users at this location.

904.4.1 Parallel Approach. A portion of the counter surface that is 36 inches (915 mm) long minimum and 36 inches (915 mm) high maximum above the finish floor shall be provided. A clear floor or ground space complying with 305 shall be positioned for a parallel approach adjacent to the 36 inch (915 mm) minimum length of counter.

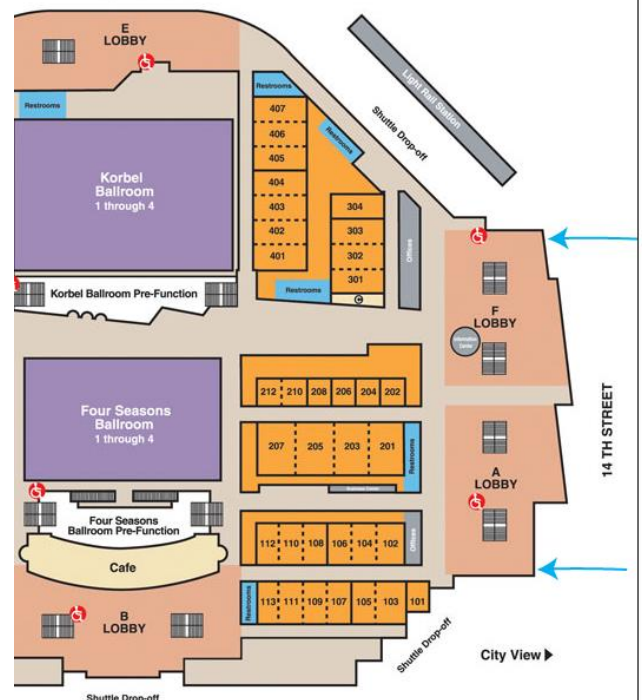
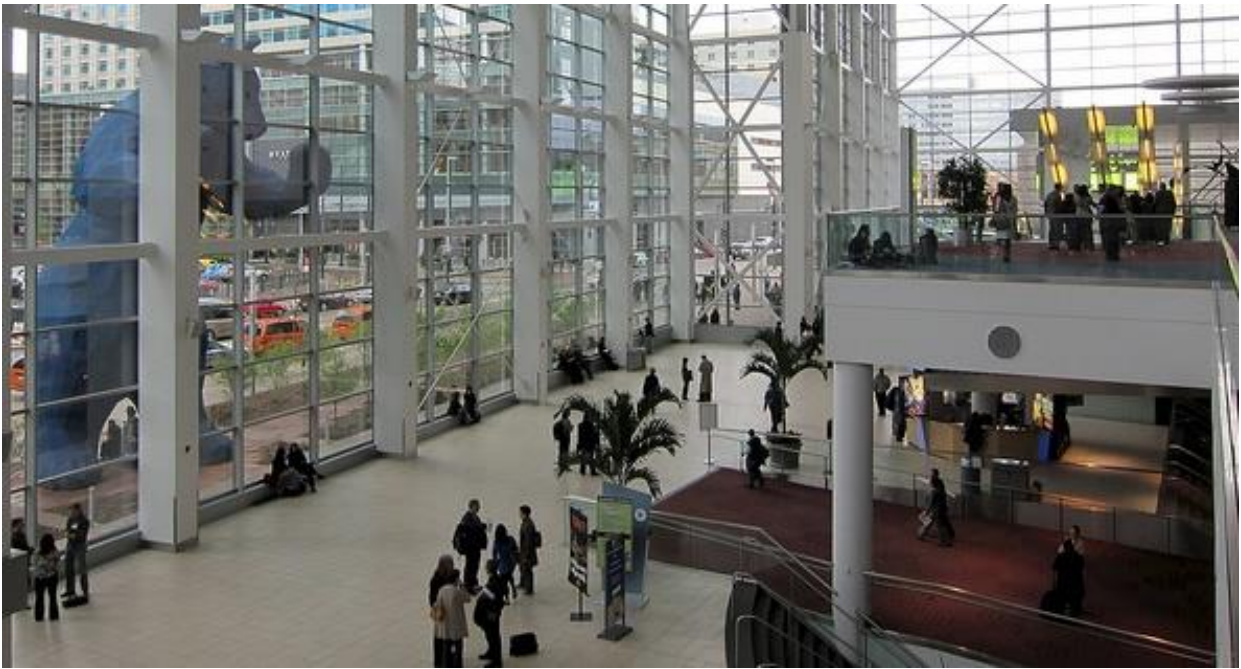
- Entrances on 14th Street are not all accessible. Provide directional signs to the accessible doors.
- Website does not include accessibility information. It does include information on other services, and should include an accessibility page with access information on:
 - Wheelchair/scooter availability and location of service
 - Accessible charging station
 - Accessible entrances and routes to other levels
 - Map of accessibility features
- Running slope of the main ramp in the lobby exceeds 8.33%, provide signage to elevators

Main ramp at center of lobby exceeds 10%

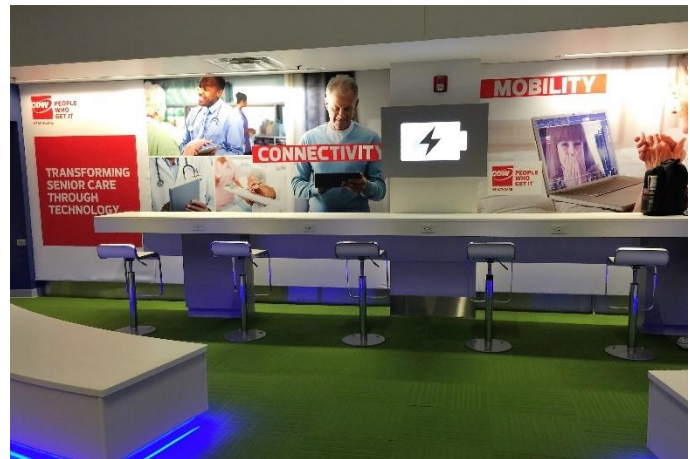
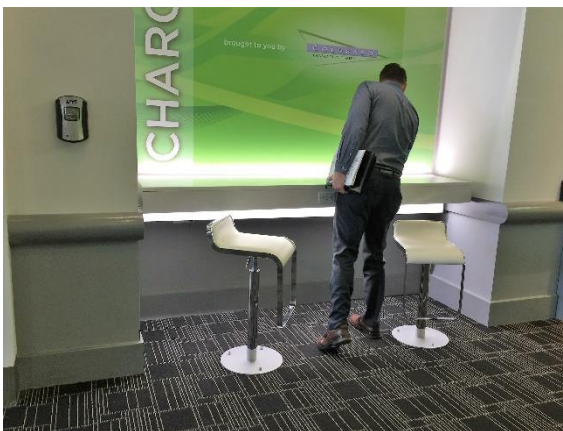
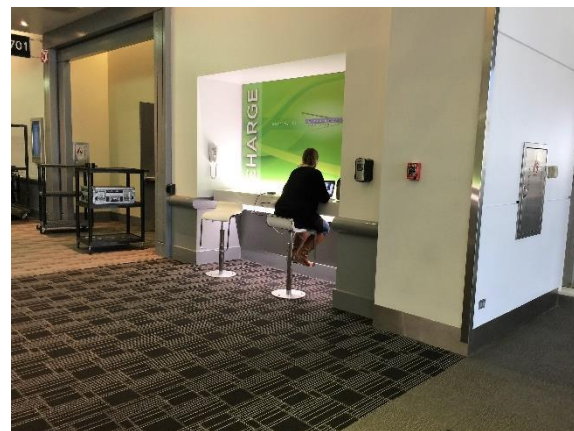
- Charging stations do not include an accessible work surface. Add at the left end of these stations with charging outlet.

902.2 Clear Floor or Ground Space. A clear floor space complying with 305 positioned for a forward approach shall be provided. Knee and toe clearance complying with 306 shall be provided.

902.3 Height. The tops of dining surfaces and work surfaces shall be 28 inches (710 mm) minimum and 34 inches (865 mm) maximum above the finish floor or ground

- Lower the height of one of these charging stations in the 700 hall to meet accessible work surface requirements, keep one space clear of seating for wheelchair use.

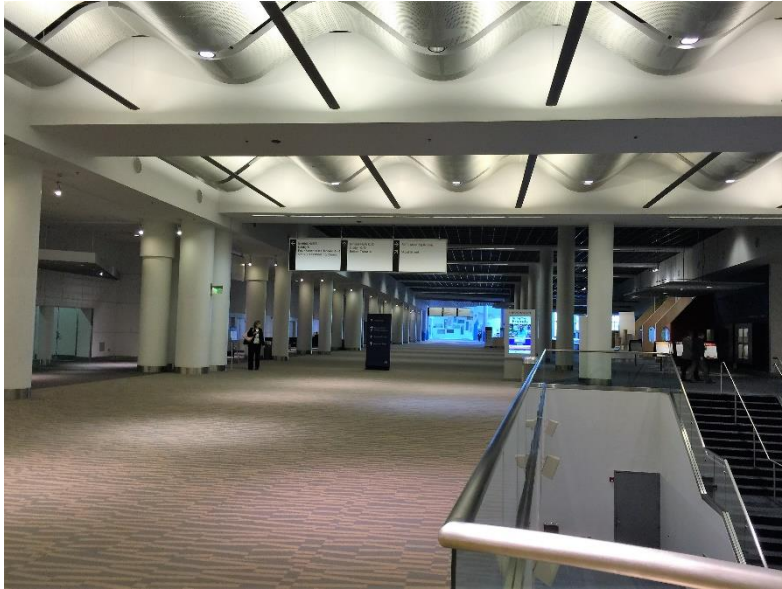
Elevator location to access ballroom

- Lower the height of the hand sanitizer adjacent to accessible charging station so that the outlet is 48" above the floor maximum.
- The elevators in the Center are not located in the central corridors with the escalators and stairs. Provide directional signage easily visible from the stair/escalator entrances. The wheelchair symbol on the maps should include an elevator symbol as well to clarify for cane users, people with strollers, etc.

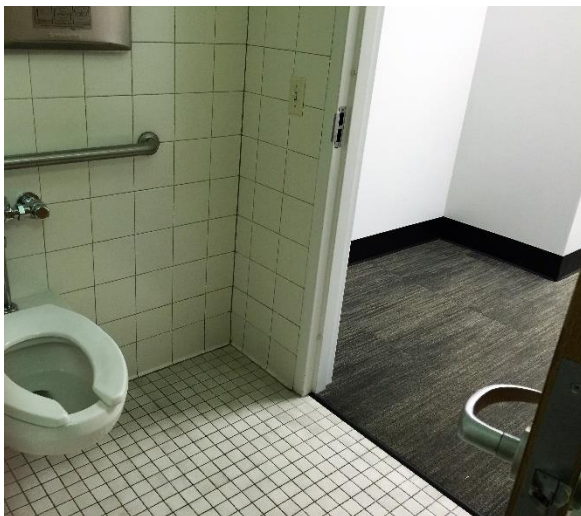
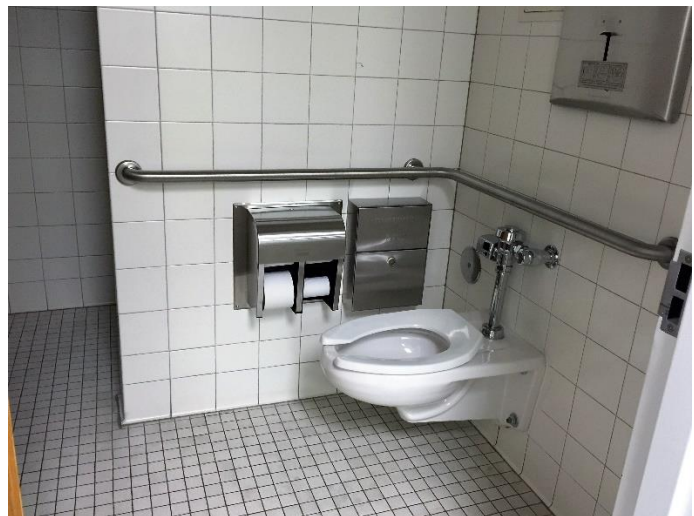
- Most of the restrooms in the Convention Center are accessible, signage with wheelchair symbol are not provided and not needed as all are accessible.
- The mezzanine has three single user restrooms, none of them meet ADA requirements. The restroom to the right as you exit the elevator includes an inaccessible shower, inadequate clear floor space at door and toilet (a wheelchair user cannot close the door). Recommend this restroom be replaced with an accessible restroom when alterations are made.

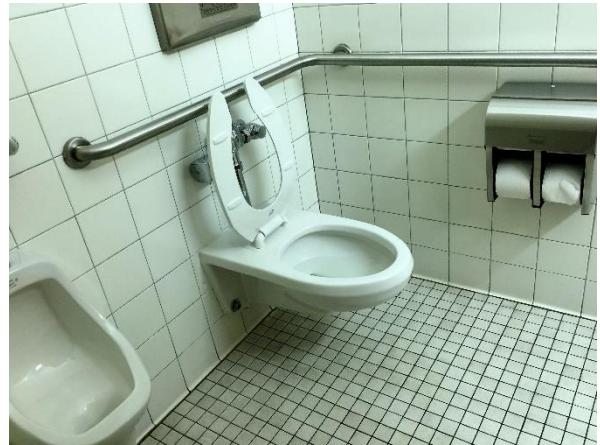
- The men's restroom on the mezzanine level does not meet ADA requirements.
 - Toilet is too far from wall
 - Urinal blocks transfer area to toilet.
 - Toilet cover dispenser is too high
 - Toilet paper dispenser sticks out too far.
- Provide a compliant toilet room when space is altered.

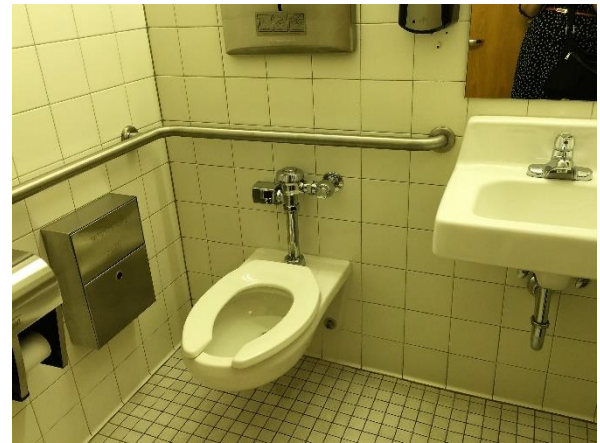
- The women's restroom on the mezzanine level does not meet ADA requirements.
 - Lavatory drain pipes are not wrapped
 - Lavatory blocks transfer area to toilet.
 - Toilet cover and soap dispenser are too high
 - Toilet paper dispenser sticks out too far.
- Provide a compliant toilet room when space is altered.

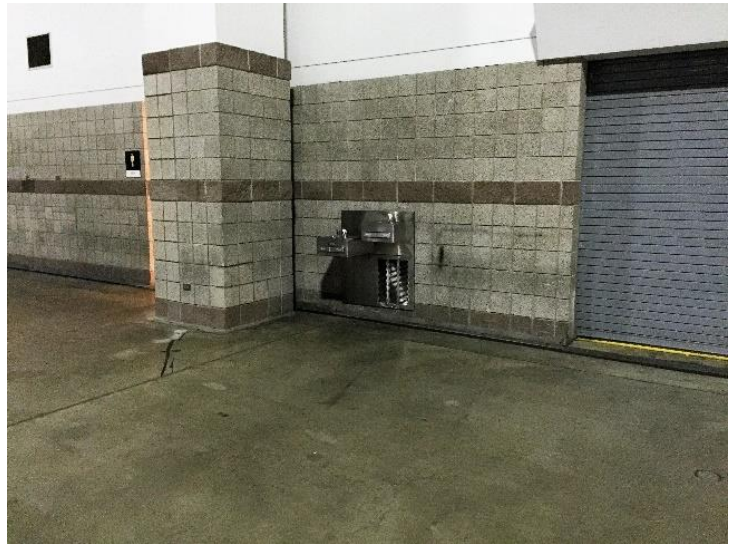
- This drinking fountain creates a protruding object on the rollup door side. Recommend adding a bollard or other furnishing on this side to create an alcove for the fountain, or add an apron to the drinking fountain to make it cane detectable.

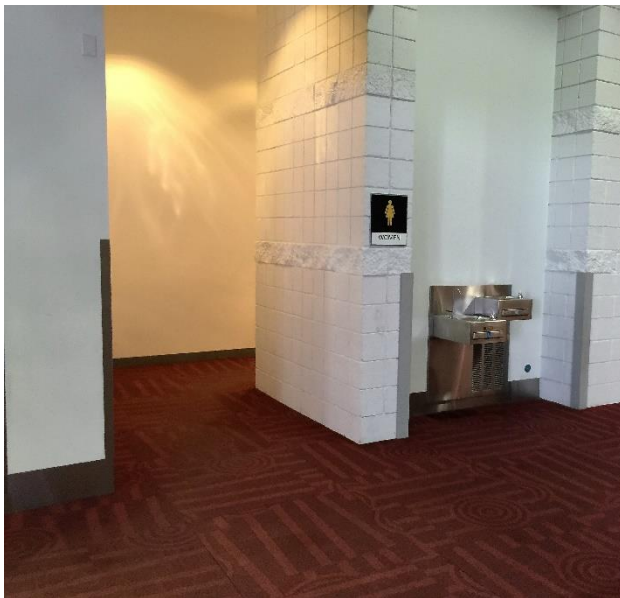
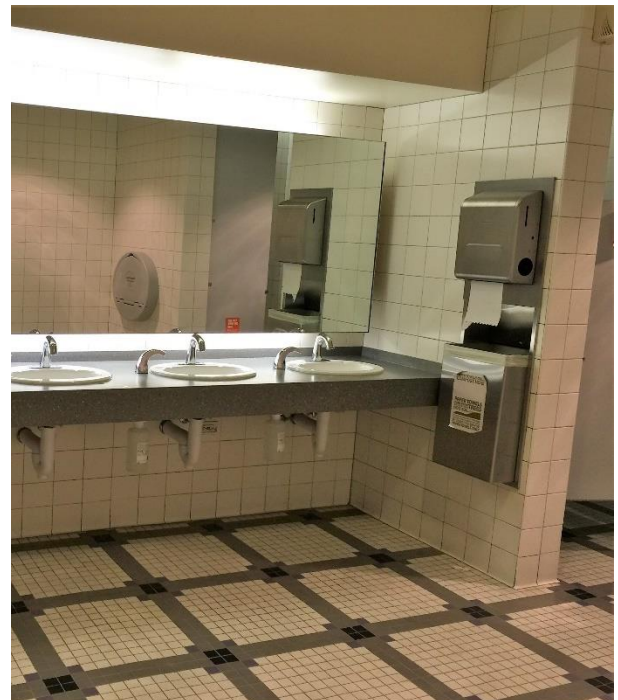
- The women's restroom between the 600 and 700 halls does not have an accessible towel dispenser. Lower one of the dispensers to have the outlet at 48" maximum above the floor.

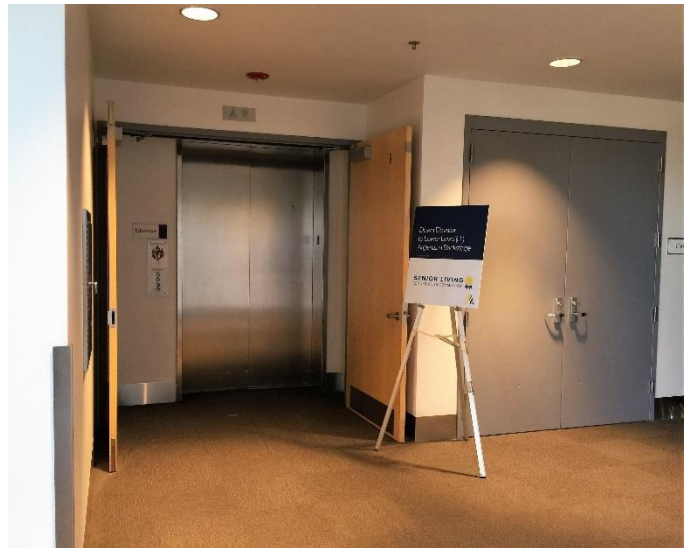
- The accessible route to the lower seating areas is by a single elevator that also serves the stage and speaker/talent green room areas.
- The elevator is not visible from the lobby and size of the signage makes it difficult to find in this expansive space. This is likely not an issue for ticketed events where patrons are directed to seating, however, for open seating events, the accessible route is difficult to find. Recommend increasing size of signage.
- The elevator is required to be available for anyone to use.
- Seating charts need to show the accessible route to the accessible seats. The route to seating areas 2 and 3 is through this elevator and through Section 1. Describe how dispersed seating is provided in Sections 2 and 3 when the theater is sectioned off and multiple programs are taking place. The ADA does not

allow discrimination because of disability, ie. Requiring a wheelchair user to travel through a program in Section 1 and 2 to get to their program in Section 3.

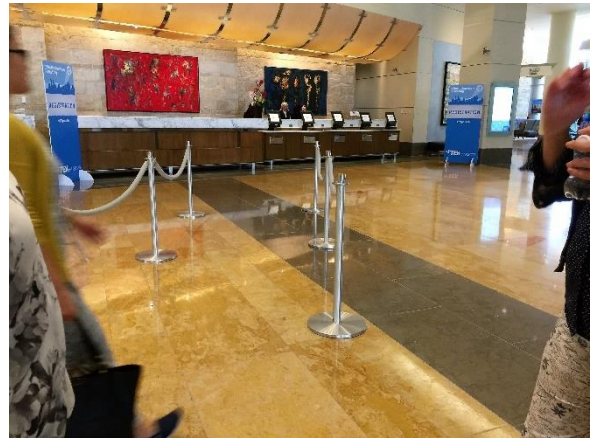
- The entrance doors and lobby space are accessible. The registration, concierge, and car rental counters are not accessible. Need to add accessible counters, temporary now, schedule permanent counter installation.

904.4 Sales and Service Counters. Sales counters and service counters shall comply with 904.4.1 or 904.4.2. The accessible portion of the counter top shall extend the same depth as the sales or service counter top.

904.4.1 Parallel Approach. A portion of the counter surface that is 36 inches (915 mm) long minimum and 36 inches (915 mm) high maximum above the finish floor shall be provided. A clear floor or ground space complying with 305 shall be positioned for a parallel approach adjacent to the 36 inch (915 mm) minimum length of counter.

904.4.2 Forward Approach. A portion of the counter surface that is 30 inches (760 mm) long minimum and 36 inches (915 mm) high maximum shall be provided. Knee and toe space complying with 306 shall be provided under the counter. A clear floor or ground space complying with 305 shall be positioned for a forward approach to the counter.

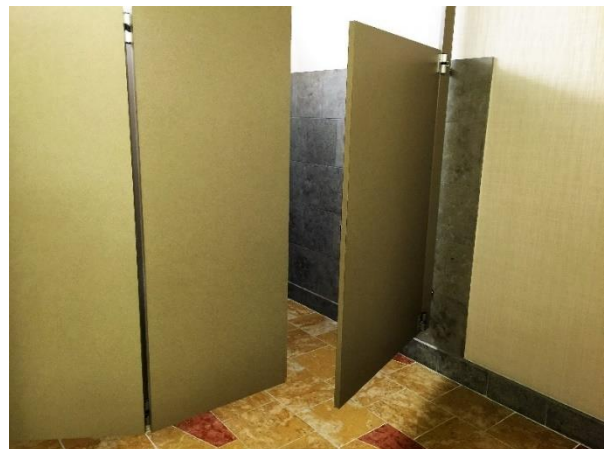
- All of the accessible compartments in all restrooms on the public floors are missing one or two door pulls. Accessible stall doors need to have pulls on both sides of the doors and the doors need to be self-closing.
- Restrooms do not have accessible ambulatory stalls in restrooms with 6 or more fixtures. Recommend converting a standard stall to a compliant ambulatory stall with door opening outward, handles on both sides, etc.

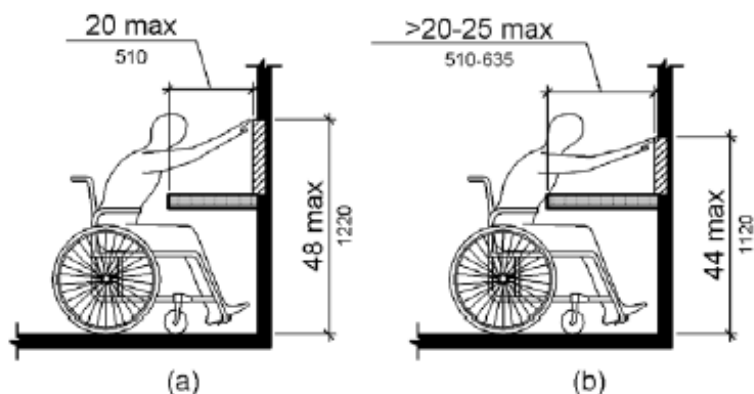
- Paper towel dispensers are too deep in the counter. Recommend placing a towel dispenser on counters behind trash hole. 25" maximum from front edge of counter.

308.2.2 Obstructed High Reach. Where a high forward reach is over an obstruction, the clear floor space shall extend beneath the element for a distance not less than the required reach depth over the obstruction. The high forward reach shall be 48 inches (1220 mm) maximum where the reach depth is 20 inches (510 mm) maximum. Where the reach depth exceeds 20 inches (510 mm), the high forward reach shall be 44 inches (1120 mm) maximum and the reach depth shall be 25 inches (635 mm) maximum.

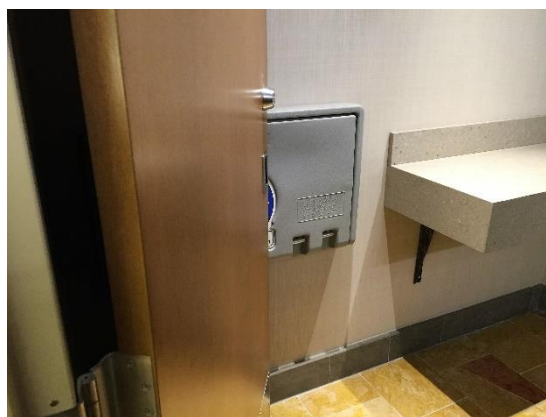
- Baby changing station is behind door to restroom stalls. When in use, access to the restroom stalls is blocked. Move to an accessible location.

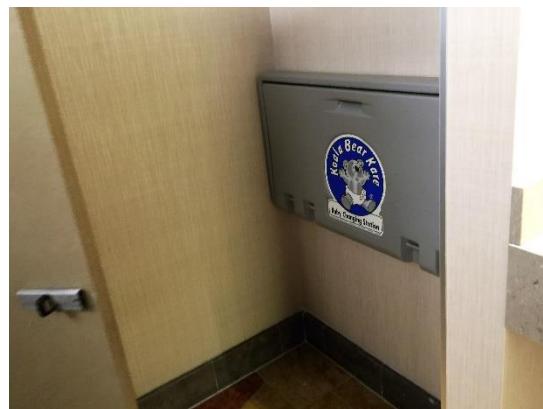
- Baby changing station is in the clear floor space in the accessible compartment. Move to an accessible location.

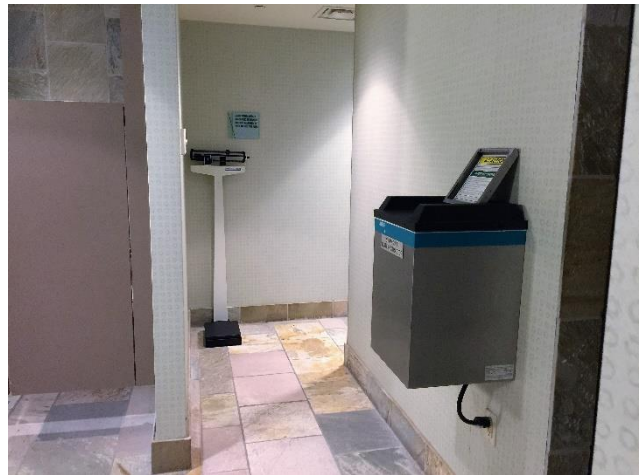
- Swimsuit water extractors in both locker rooms block the accessible route through the space.
- Scale in women's locker room is in accessible route. Move to a clear area.
- Showers in both locker rooms do not meet ADA requirements.

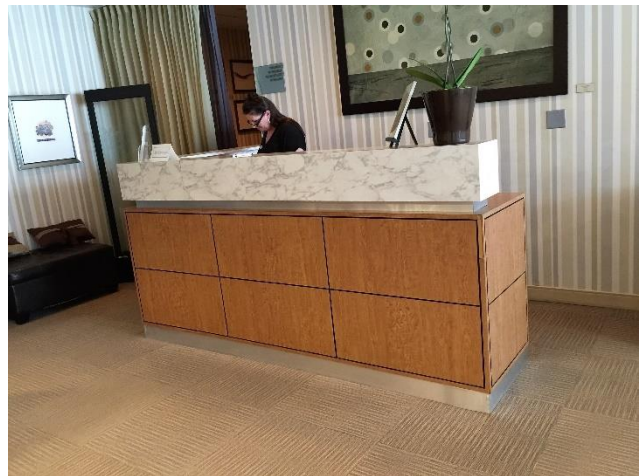
- Spa counter is not accessible. Add a compliant counter.

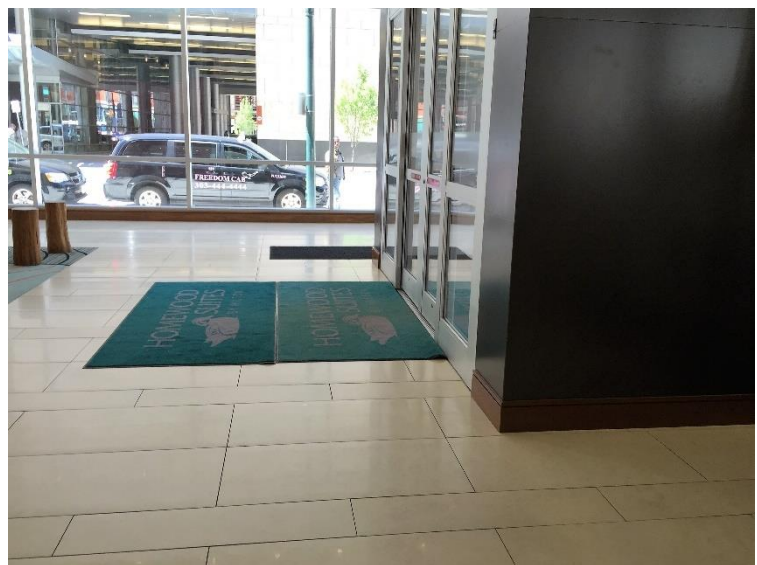
- The entrance is accessible, however, the movable mats at the door do not meet the requirements for a firm and stable surface

302.1 General. Floor and ground surfaces shall be stable, firm, and slip resistant and shall comply with 302.

302.2 Carpet. Carpet or carpet tile shall be securely attached and shall have a firm cushion, pad, or backing or no cushion or pad. Carpet or carpet tile shall have a level loop, textured loop, level cut pile, or level cut/uncut pile texture. Pile height shall be ½ inch (13 mm) maximum. Exposed edges of carpet shall be fastened to floor surfaces and shall have trim on the entire length of the exposed edge. Carpet edge trim shall comply with 303.

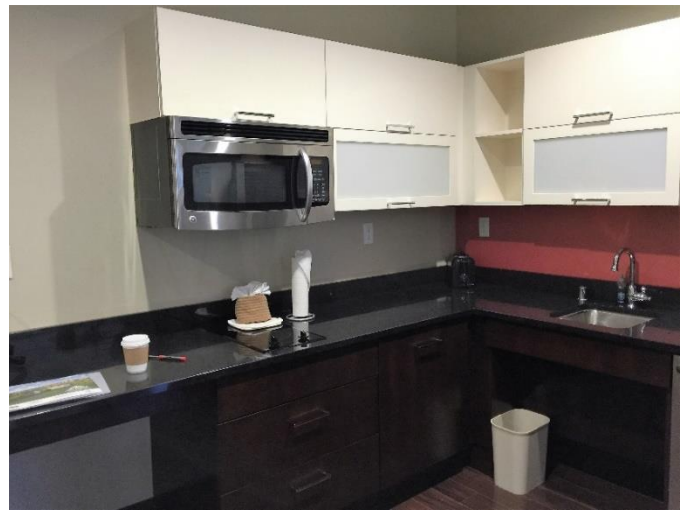
- The suites are very spacious and the unit we reviewed was very accessible.
- The microwave in the kitchen is not accessible. Recommend adding a countertop microwave to all accessible suites.

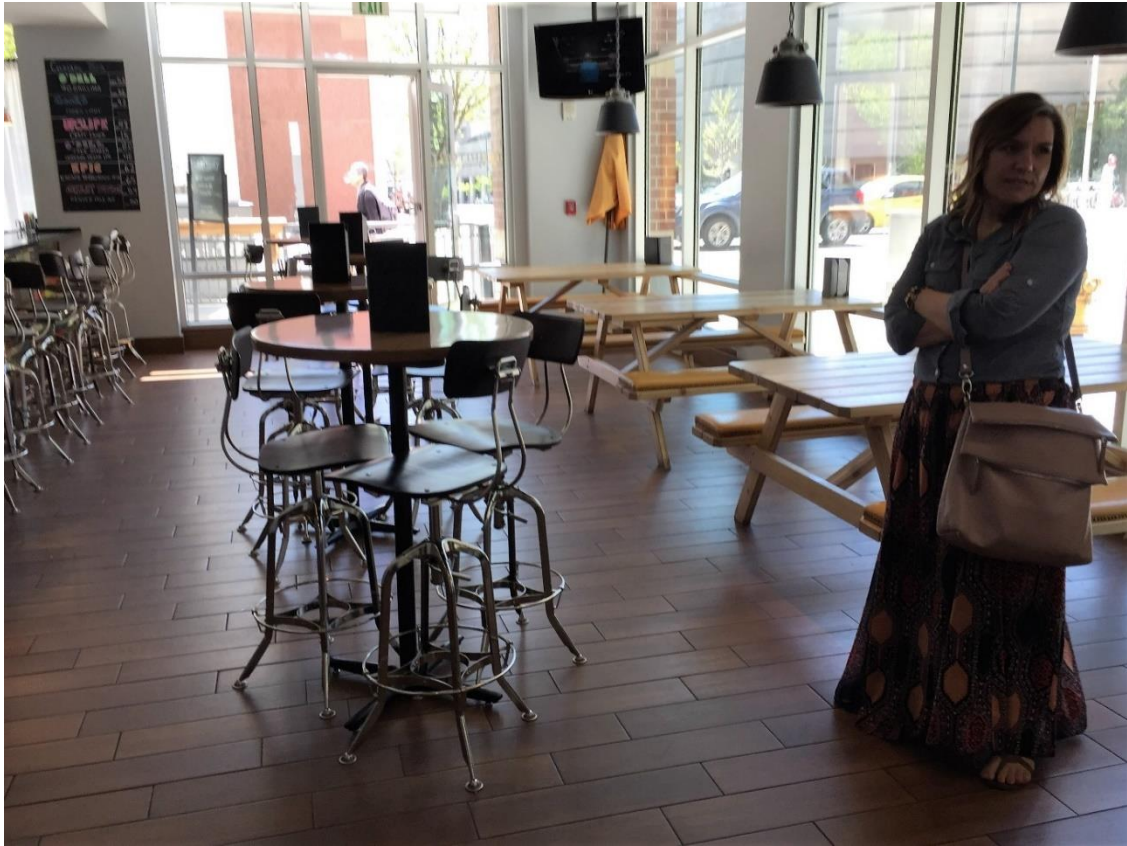
- There are no accessible tables or bar space in the dining area. Add accessible tables on an accessible route with adequate maneuvering and clear floor space.

902.3 Height. The tops of dining surfaces and work surfaces shall be 28 inches (710 mm) minimum and 34 inches (865 mm) maximum above the finish floor or ground.

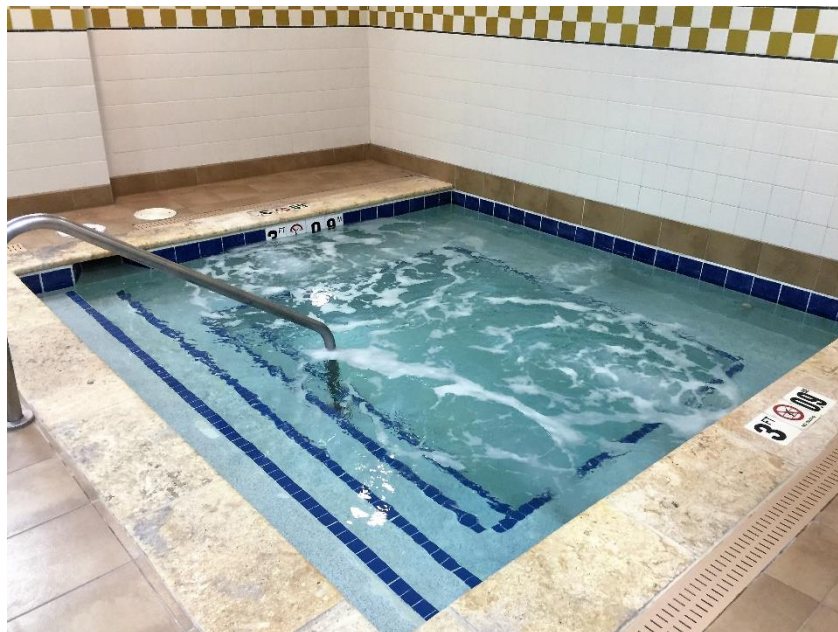
- There is no lift for the hot tub. Add a lift for this spa as required by the 2010 ADA Standards.

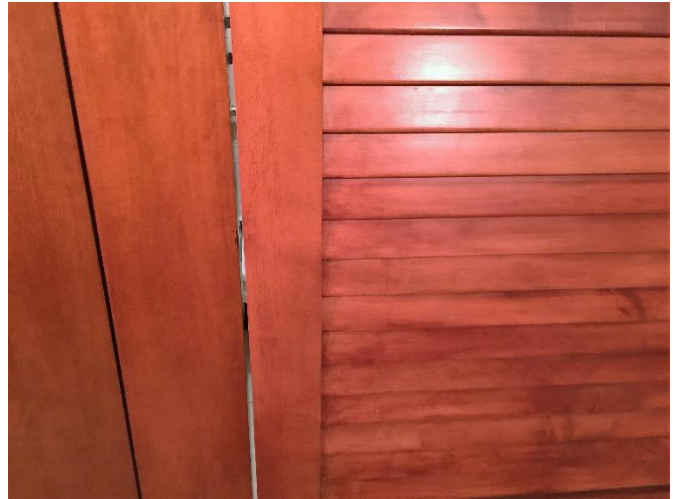
- There are no door pulls on the accessible compartment doors in the lobby restrooms. Add a door pull on the inside and outside of doors.

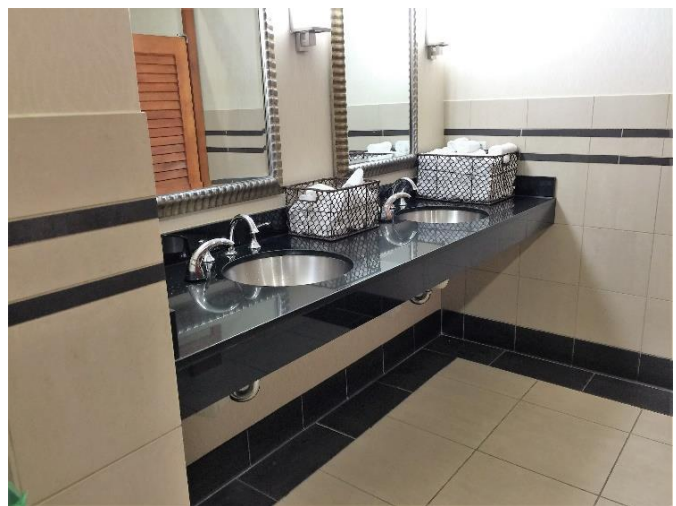
- Mirrors are mounted higher than 40" above floor.
- Lavatory pipes and supply lines are not wrapped

606.5 Exposed Pipes and Surfaces. Water supply and drain pipes under lavatories and sinks shall be insulated or otherwise configured to protect against contact. There shall be no sharp or abrasive surfaces under lavatories and sinks.
