### **Rosen Center Hotel and Conference Center**

## **Accessibility OBSERVATIONAL ADA Site Survey of venues with the AAPMR Event Planning Team for the October 2018 Conference in Orlando, FL.**

Site Visit: April 17-19, 2017

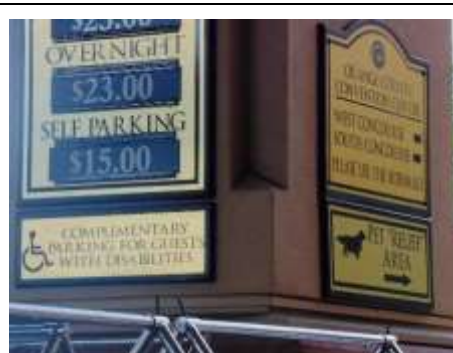
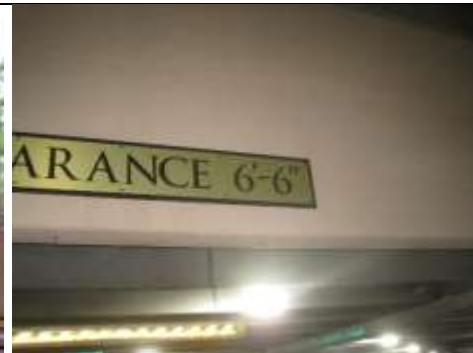
Complimentary parking for Guests with Disabilities  
78" high garage clearance. **NOT VAN ACCESSIBLE**

**502.5 Vertical Clearance.** Parking spaces for vans and access aisles and vehicular routes serving them shall provide a vertical clearance of **98 inches** (2490 mm) minimum.

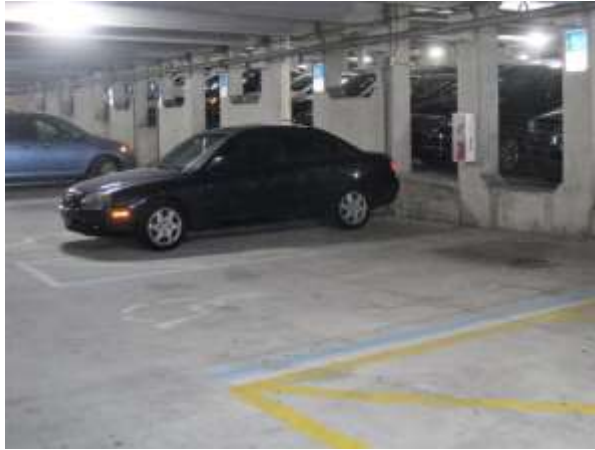
There are some accessible surface level parking spaces near the front entry lot and in the back-service lot area.

Accessible aisles, accessible path, signage, and accessible parking spaces **DO NOT** meet 2012 Florida Accessibility Standard. *I did not field measure.*

**Disabled Guests must walk behind other parked cars.**

**No designated accessible path.**

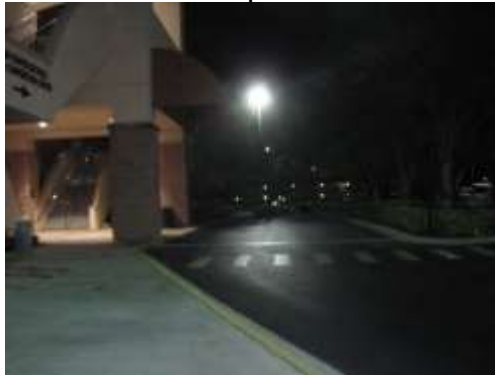
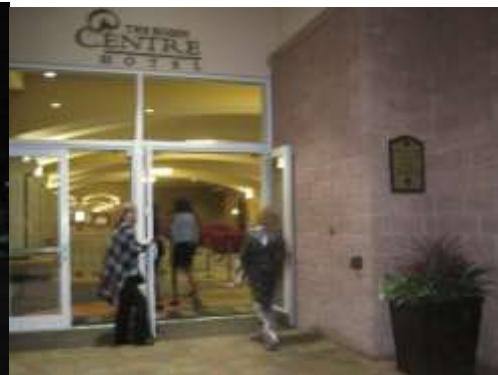
## REAR ENTRANCE AT PARKING GARAGE AND CONFERENCE CENTER

Drop off.

Automatic door opener.

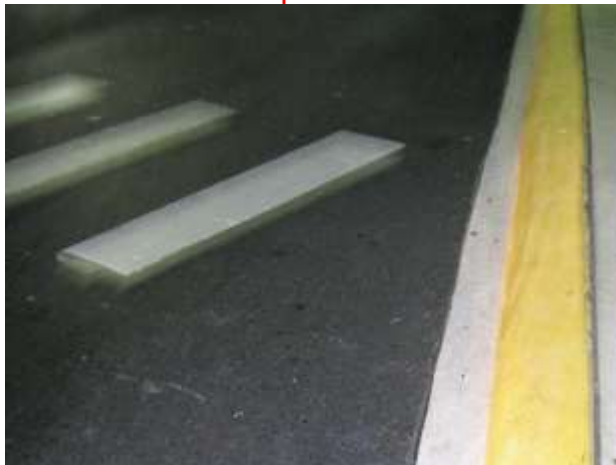
**Painted accessible path leads to a RAISED CURB.**

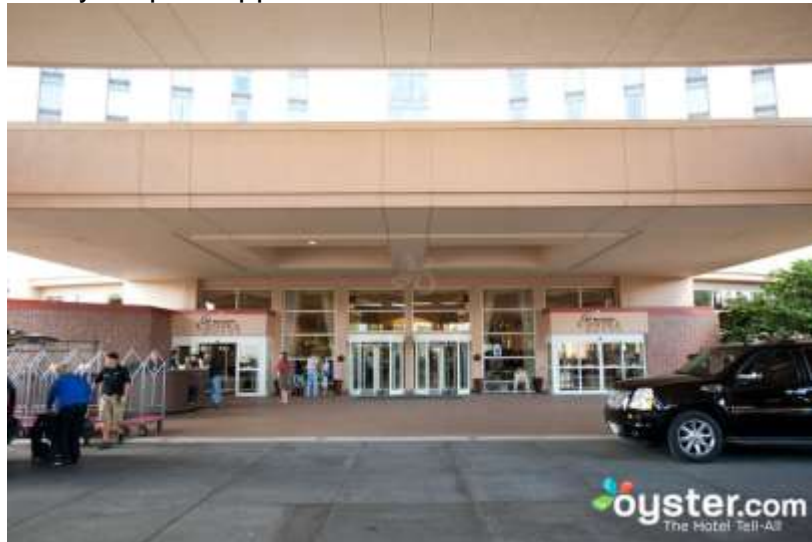
**FRONT  
ENTRANCE AT  
LOBBY**

Lobby drop off appears to meet ADA Standards.

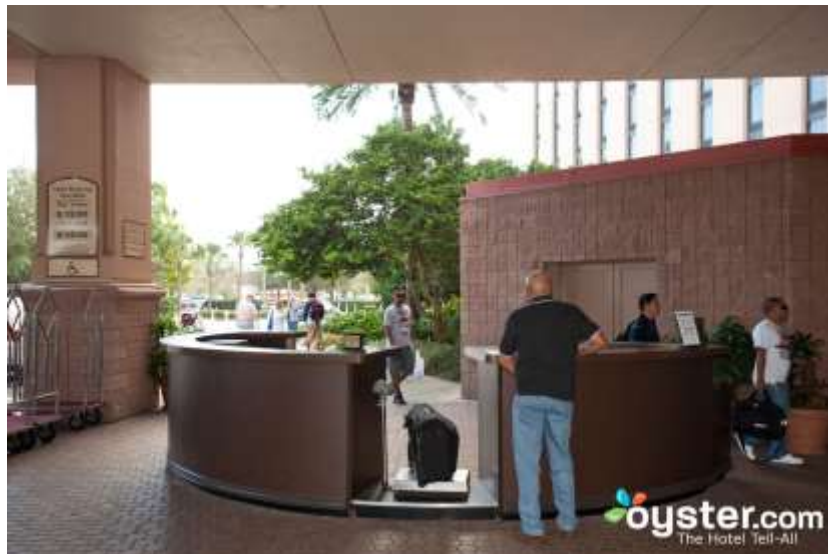
Valet key drop area counter has a lowered counter for ADA Standard. *Not measured.*

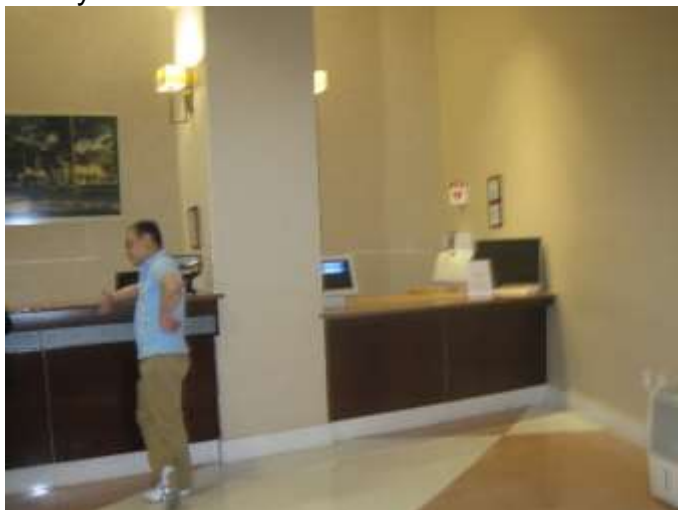
Lobby front desk has a lowered accessible counter. *Not measured.*

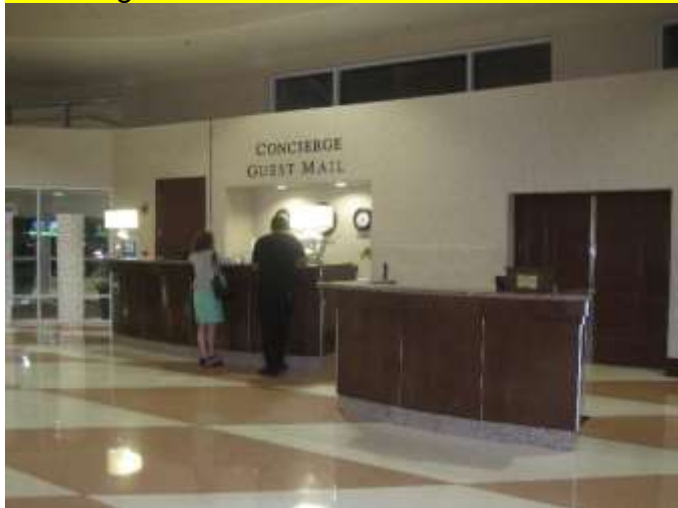
Concierge **DOES NOT** have a lowered accessible counter

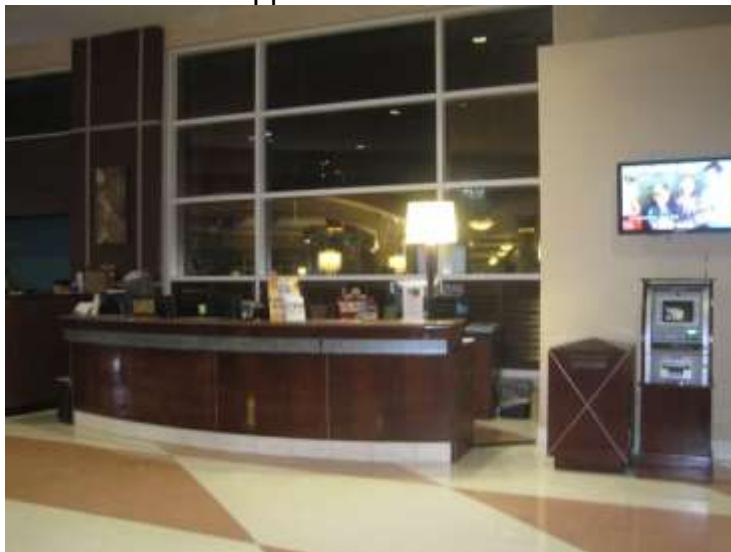
Ticket Concierge **DOES NOT** have a lowered accessible counter  
Trash and ATM appear accessible

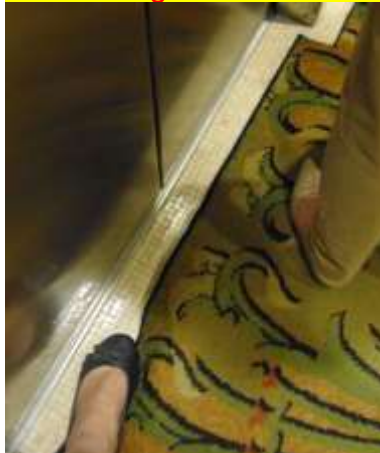
### Lobby Elevators

The elevators appeared to meet ADA Standards

A loose rug in one elevator is an accessible tripping point.

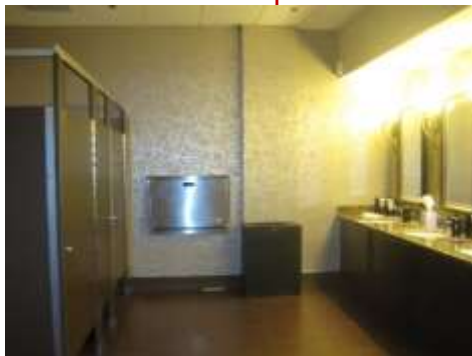
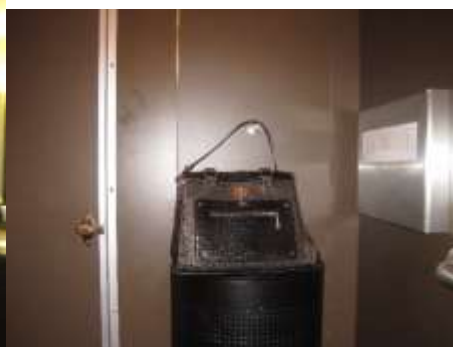
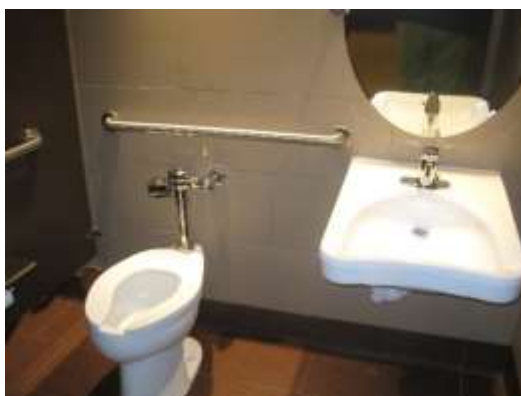
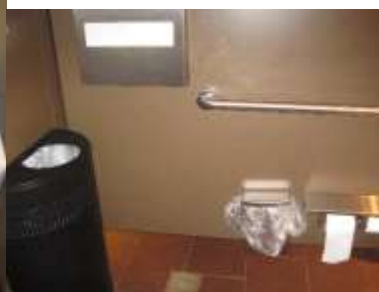
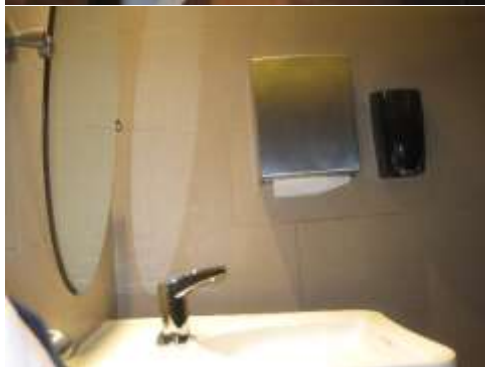
If changing table is in use, it blocks entry and exit to the accessible toilet.

No handle inside stall door.

trash an under the purse/coat hook makes it non-useable.

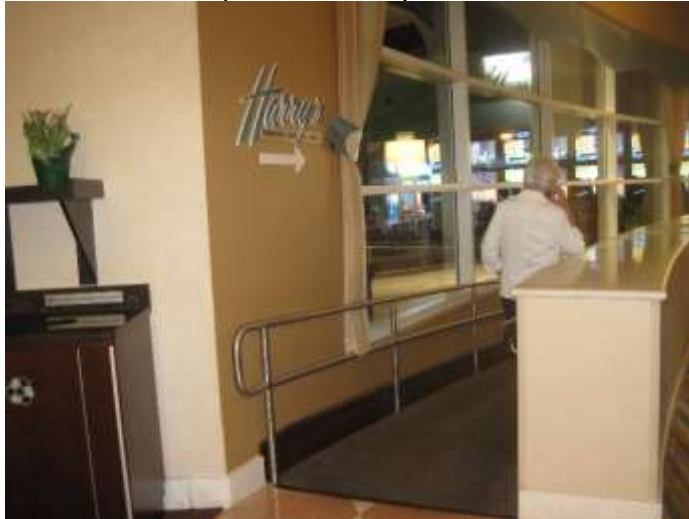
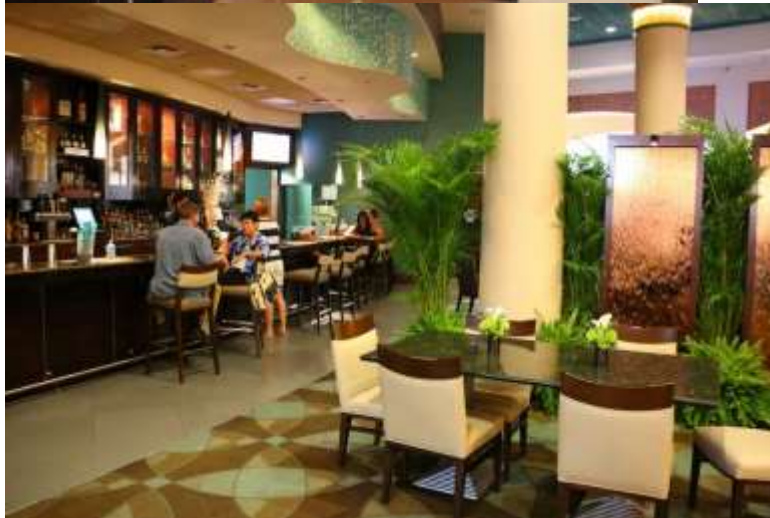
### Sam and Bubbe's Lobby Side Bar & Lounge

**Does NOT have accessible bar seating.**

Accessible ramp to bar and pool bar door.

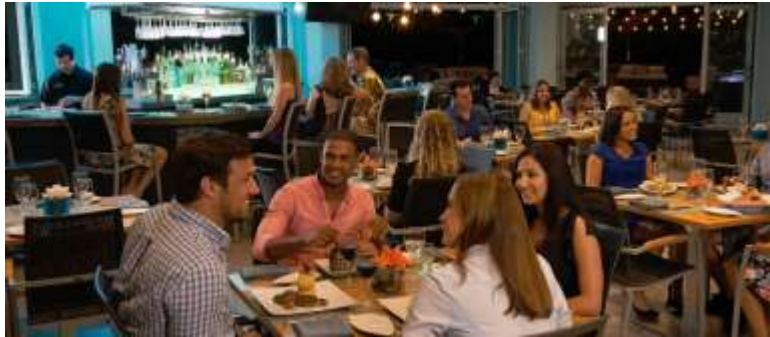
### Harry's Pool Side Bar

Does NOT have accessible bar seating.

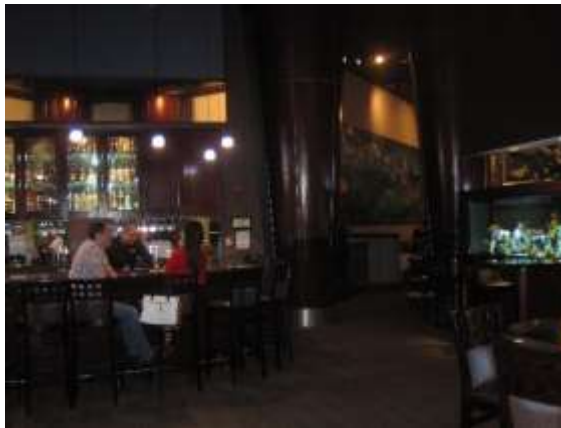
### EVERGLADES

The bar DOES NOT have accessible bar seating and all of the bar tables are non-accessible high tops.

The restaurant has accessible seating.

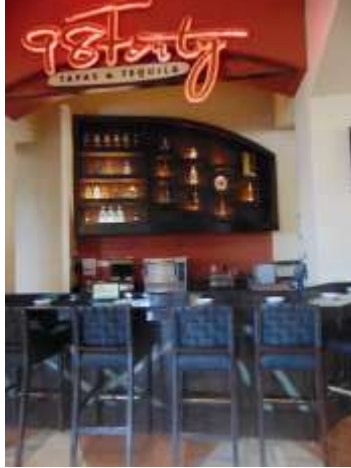
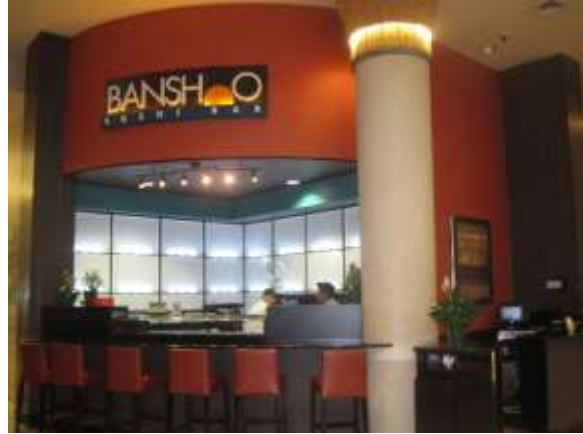
### 98 Forty

No accessible bar seating.

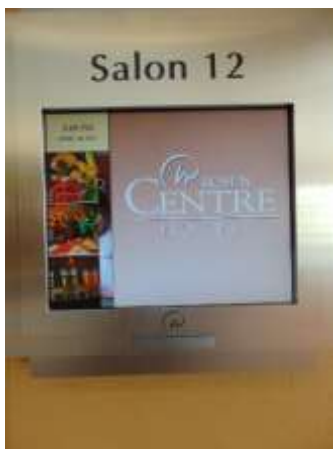
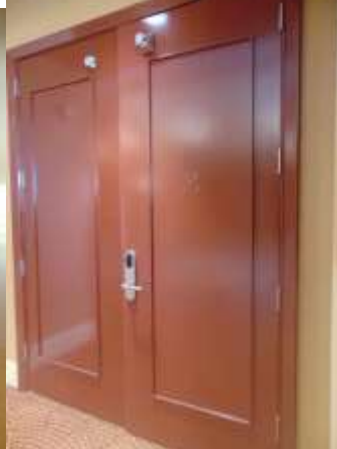
Clear Signage. Raised Letters should be lower per ADA Standards. Braille.

No accessible peepholes in meeting room doors.

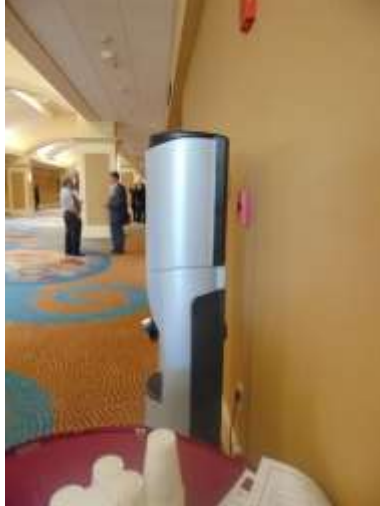
Water cooler blocking fire pull access.

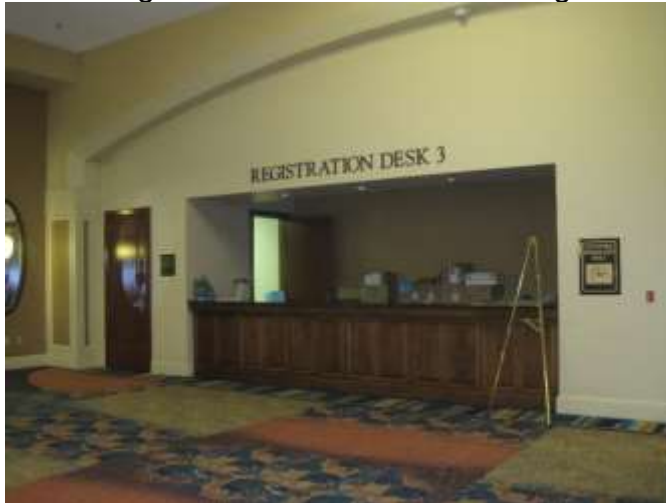
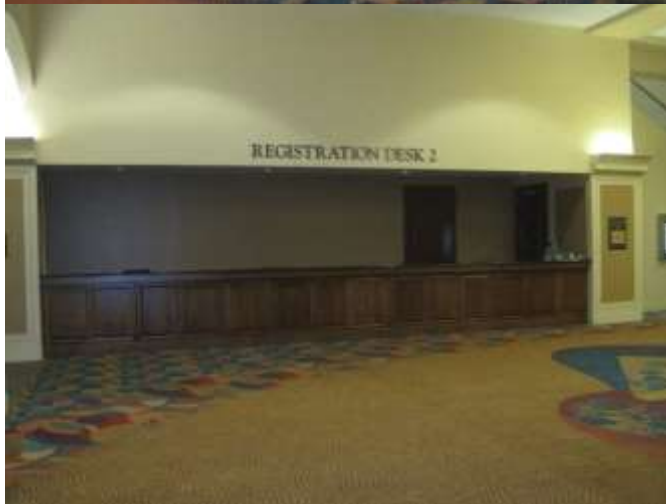
The 3 Registration desks look a little higher than 36" high. *Not measured*

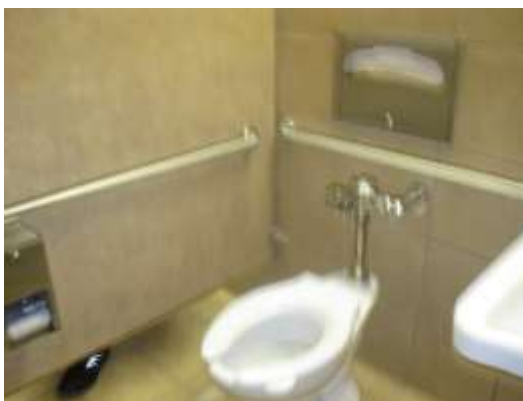
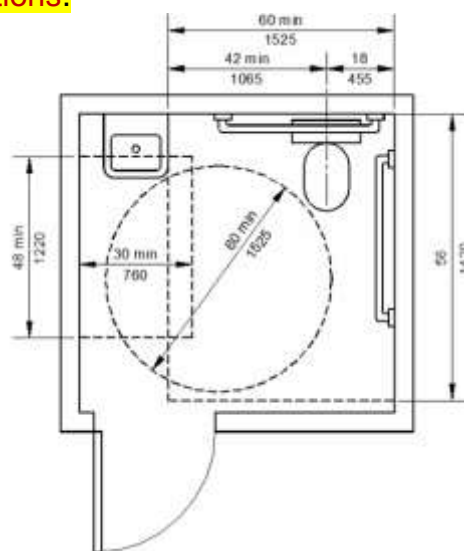
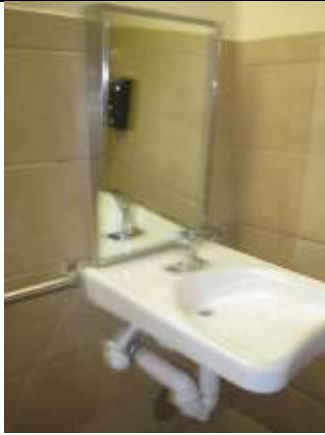
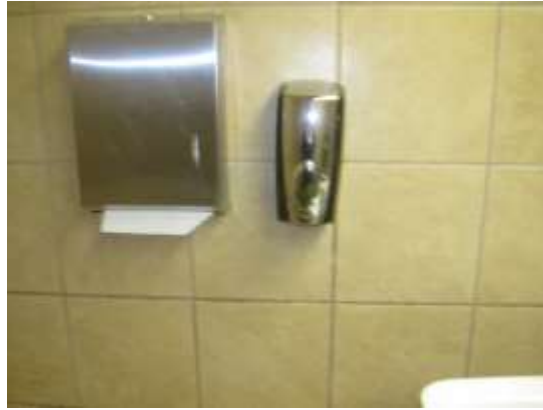
Accessible entry. ADA Standard signage.

Seat dispenser in ADA obstructed reach range Standard.

Sink is very close to toilet. It might be designed for 1991 ADA Standard.

Does not meet current guest expectations.

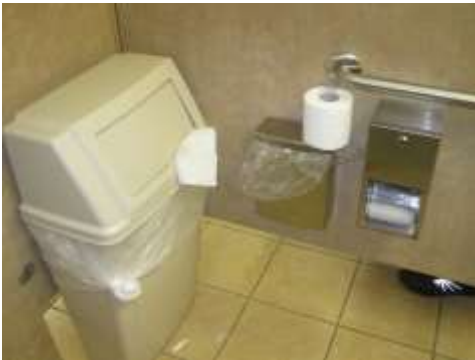
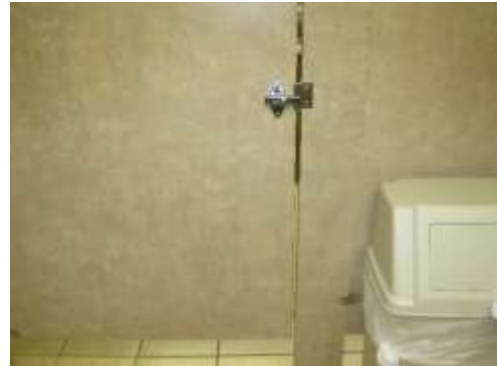
Trash can impacts clear floor space and access to the door.  
NO door handle on inside. 2010 ADA Standard.

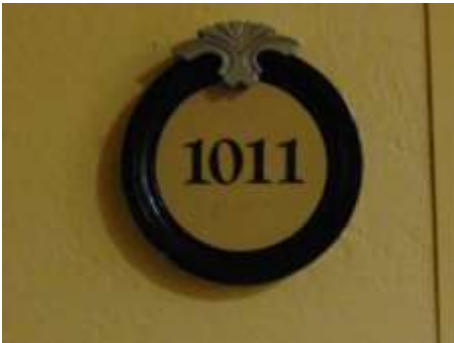
## ACCESSIBLE GUEST ROOM 1011

Mobility Accessible  
Room.  
No doorbell for  
Communication  
Accessible.

Accessible peep hole. Accessible door hardware. Braille and raised room  
identification signage.

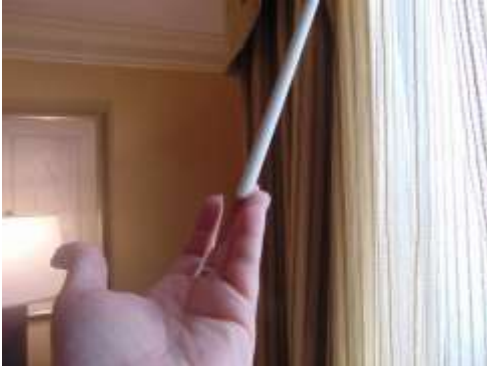
NON- Accessible drapery controls

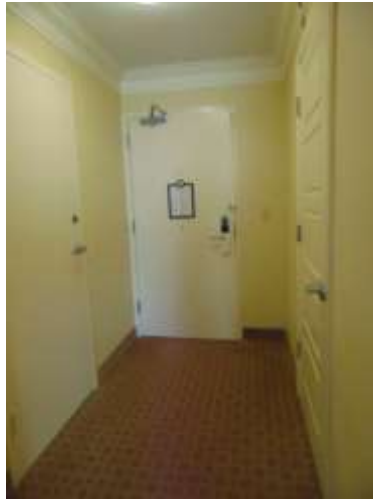
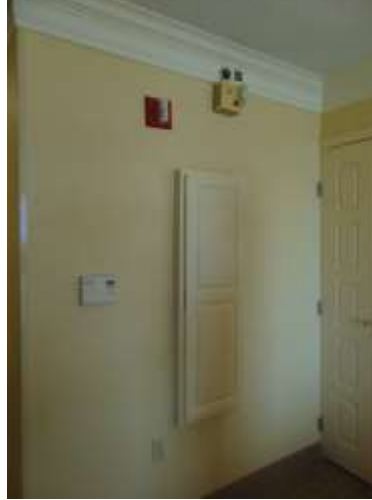
Clear access and approach at doors.

ADA Compliant hardware.  
Latch within ADA forward reach standards.  
Strobe alarms.  
Access to room thermostat

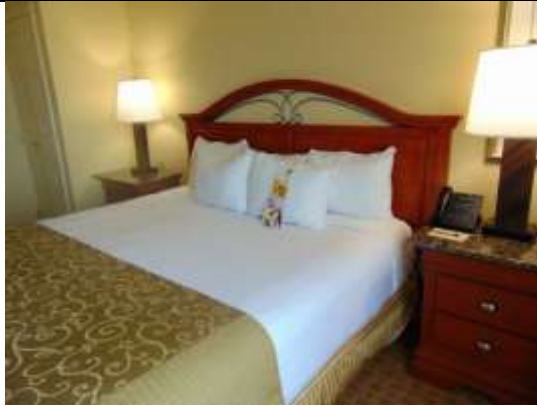
36' clear required at each side of the bed. The closet side of the bed might be a little tighter than 36" in front of the nightstand.

Easy pulls on furniture.

Open frame bed. Comfortable height bed.

Extra outlet at nightstand.

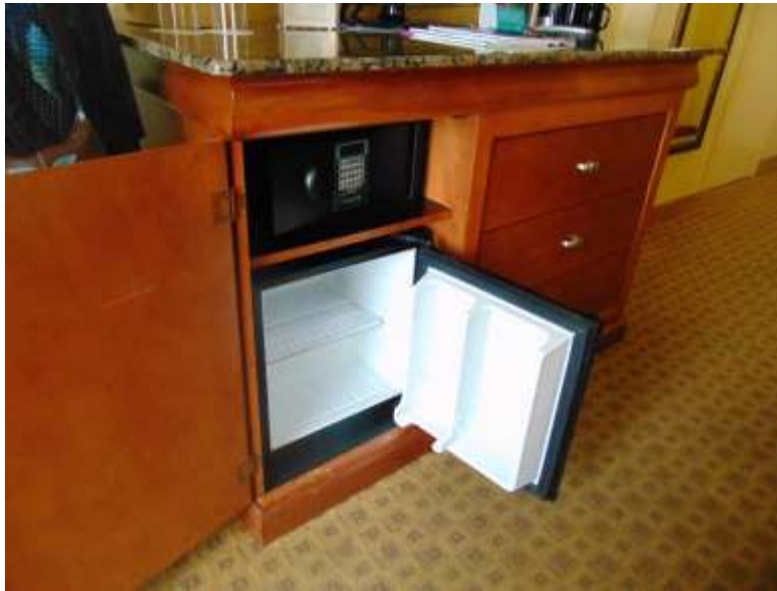
The safe is accessible.

The coffee pot should be on a 34" high counter.

Most guests would believe that the refrigerator is NOT accessible. The door shelves are not accessible.

It does meet the ADA standard of 50% of the refrigerator space between 15" and 48" above the finished floor. I recommend adding a taller refrigerator to the accessible rooms.

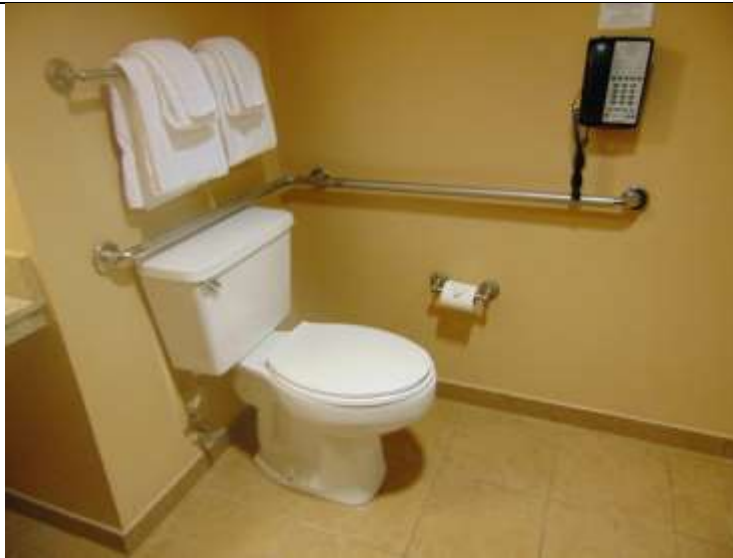
If the grab bars are mounted at 34" to 36" high with 12' clear above, there is a very good chance that the towel bar is above the 48" un-obstructed forward reach. It is higher than the 44" obstructed forward reach.

The rear grab bar should extend 24" to the open side from the center of the toilet.

The toilet paper roll is mounted too close to the toilet.

The telephone is located within the 12" of clear space required over the grab bar.

The rear toilet grab bar does not meet the 2010 ADA Standard  
The toilet paper is too close to the toilet.

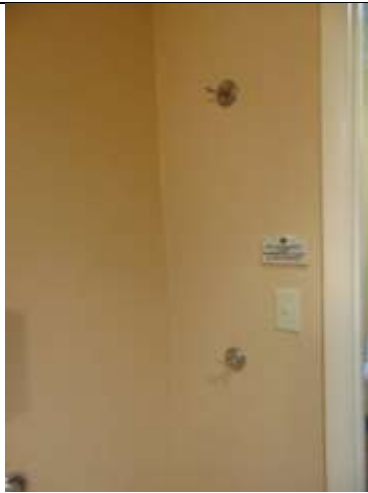
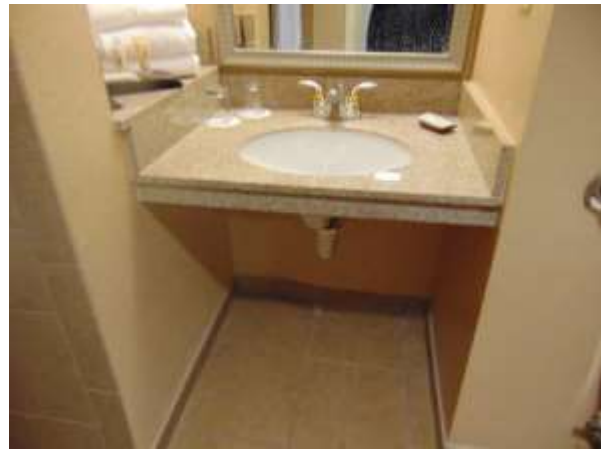
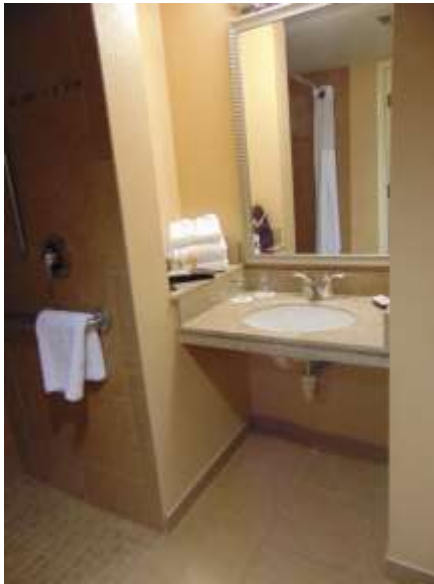
The robe hook is accessible.

The clear width at the sink does not look like 30". Verify. *Not measured*

The uneven floor angled under the sink does not allow for a flat surface for accessible wheelchair approach.

The pipes need to be wrapped.

I *did not measure* the top height of the vanity. It looks close to 34" since it is lower than the grab bar. The clear knee height looks good.

I did not observe an electrical outlet near the sink.

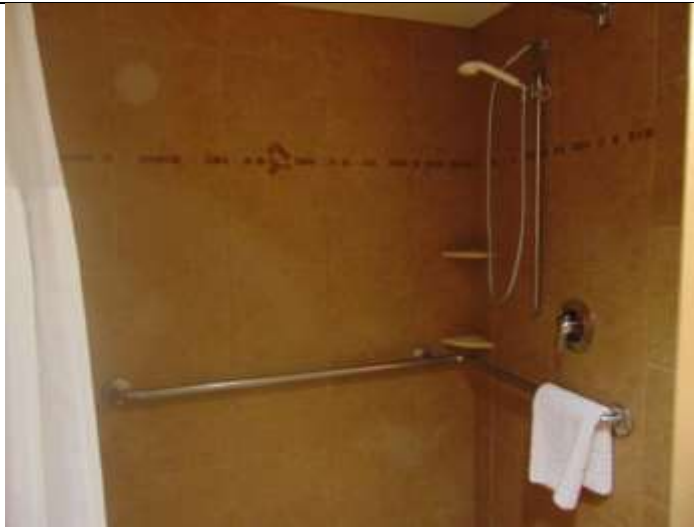
The shower does not meet either the 1991 ADA Standard or the 2010 ADA Standard for a roll in shower.  
I did not measure the shower for 36" width.

The shower hose might be shorter than 59". It doesn't look long enough to reach someone's toes at the other end of the tub.

The shower controls and hand held shower are located on the wrong wall to meet either 2010 ADA Standard or the 1991 ADA Standard

NO PERMANENT SEAT in the accessible roll-in shower. NO SHOWER SEAT IN ROOM. Residential type shower seats MAY NOT be used.

Housekeeping needs to leave the adjustable shower head mounted below 48" a.f.f.

With a permanent shower seat, the existing grab bar needs to be shorter per the Figure 608.3.2. The grab bar should not be above the seat.

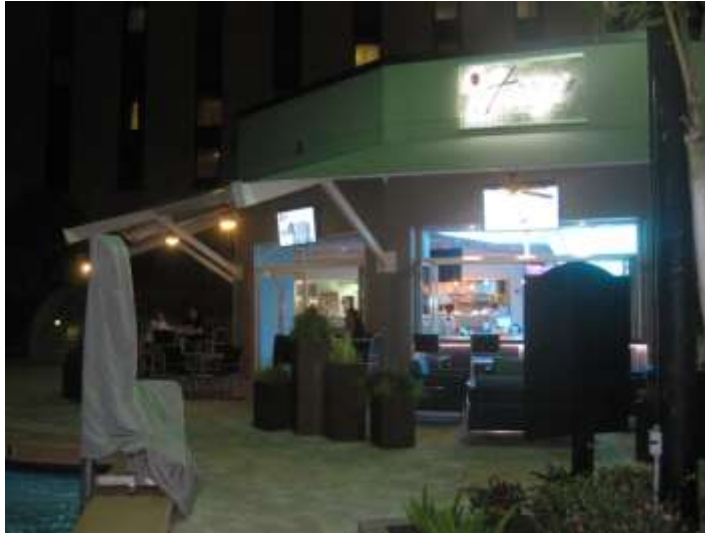
## POOL AREA

I only saw one pool lift.

ADA Standard requires 2 different means of access to a pool larger than 300-foot perimeter.

When the pool is open to guests, access **MUST** be available without assistance.

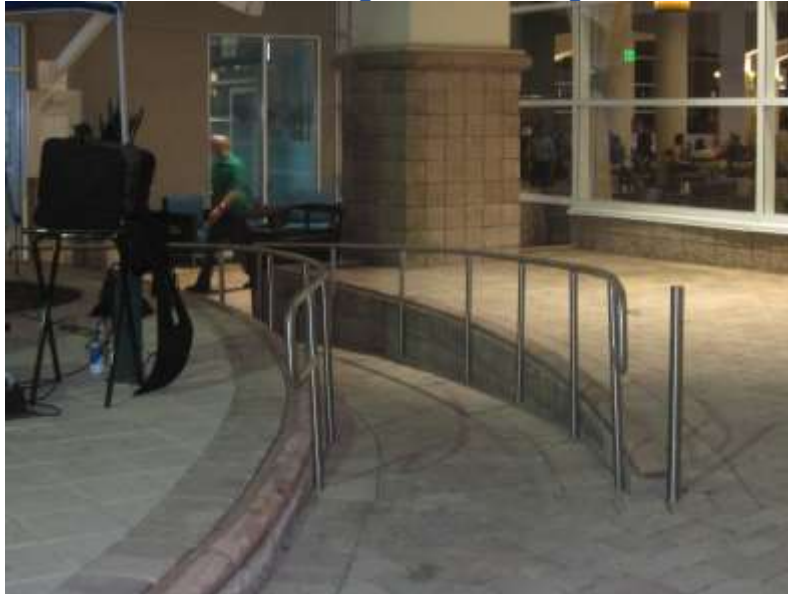
Accessible ramp to pool deck. I am not sure why there is an uncapped vertical post.

*I did not measure the height of the railing, but it felt short.*
