AAPM&R 2017 Annual Assembly and Technical Exhibition

Cursory ADA Facility Survey Report

May 11 and 12, 2016

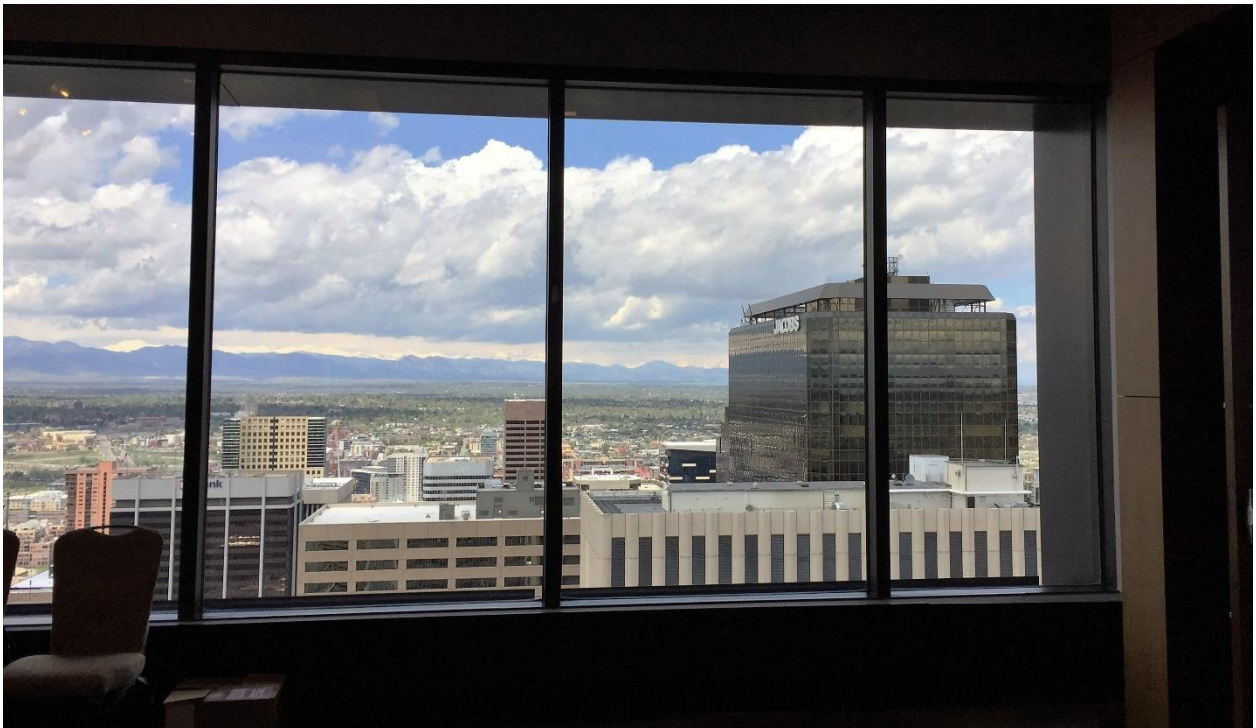
- The Pinnacle Club is located on the top floor of the Hyatt with accessible, expansive views on all sides.

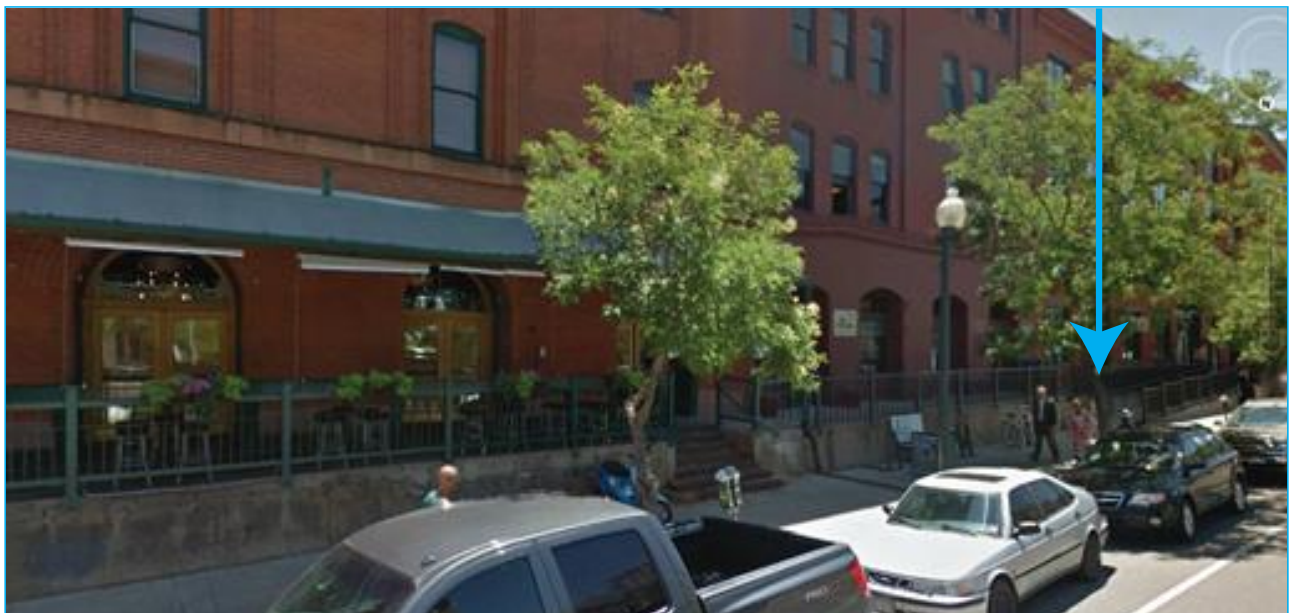
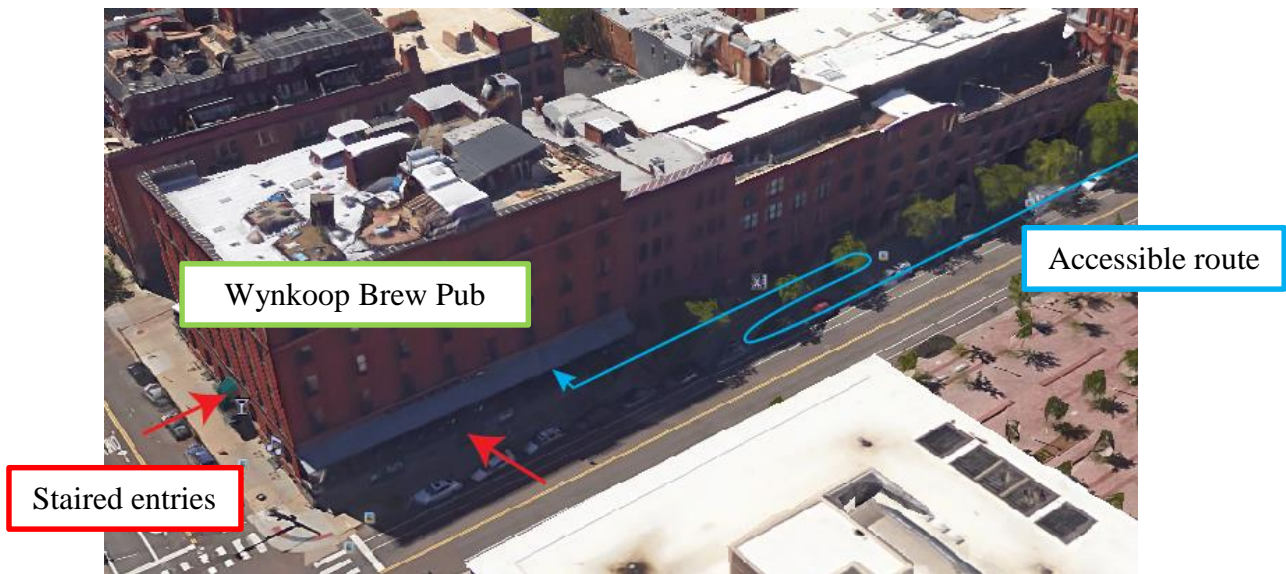
Accessible ramp to the Wynkoop

- The accessible route to the Wynkoop is by a ramp located on Wynkoop St. at mid-block.

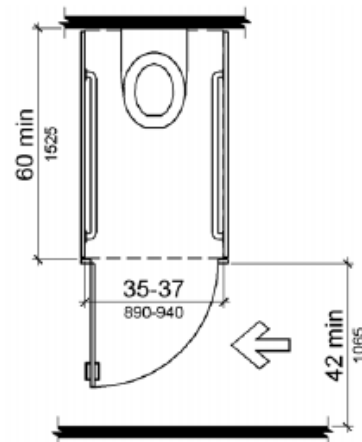
Figure 604.8.2 Ambulatory Accessible Toilet Compartment

- Second floor restrooms have most required accessibility features, elements that need to be addressed:
 - Entrances have very high thresholds. Replace with ½" beveled maximum.
 - Both restrooms have 6 or more fixtures, they need a wheelchair accessible compartment (provided) and an ambulatory compartment (not provided). Modify one stall in each restroom to be an ambulatory stall that opens outward with handles on both sides of door.

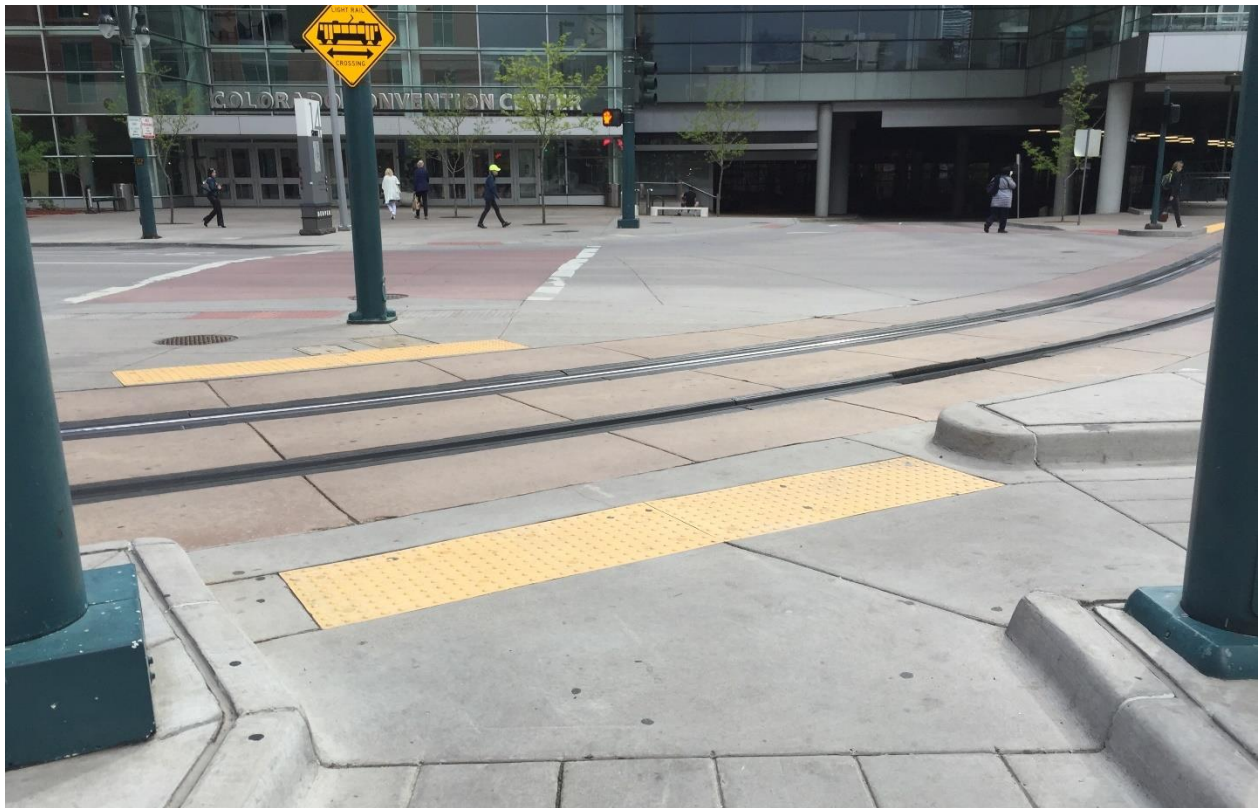
- The accessible route to the convention center from this hotel requires crossing two sets of light rail tracks. They are compliant with tactile warning strips on each side, rail gaps are approximately 3" wide.

One of the light rail crossings from Embassy Suites to the Convention Center

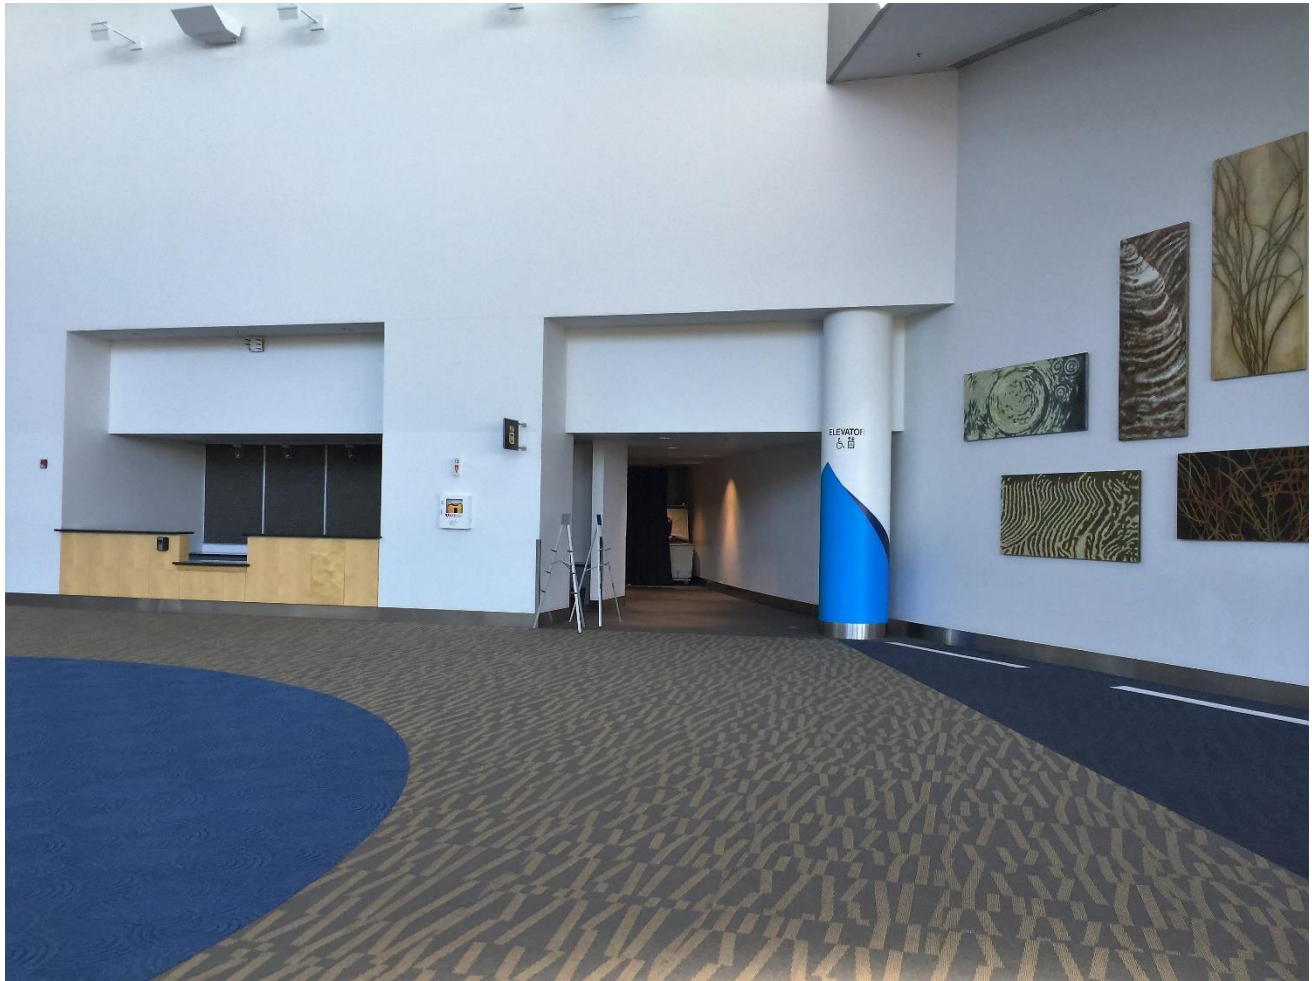
Elevator location for Belco Theater

- The accessible route to the lower seating areas is by a single elevator that also serves the stage and speaker/talent green room areas.
- The elevator is not visible from the lobby and size of the signage makes it difficult to find in this expansive space. This is likely not an issue for ticketed events where patrons are directed to seating, however, for open seating events, the accessible route is difficult to find. Recommend increasing size of signage.
- The elevator is required to be available for anyone to use.
- Seating charts need to show the accessible route to the accessible seats. The route to seating areas 2 and 3 is through this elevator and through Section 1. Describe how dispersed seating is provided in Sections 2 and 3 when the theater is sectioned off and multiple programs are taking place. The ADA does not

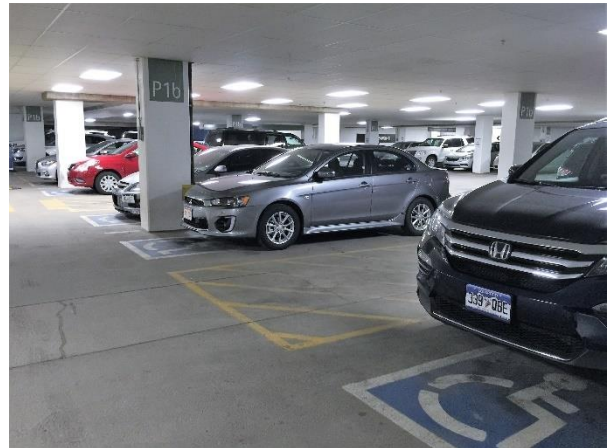
- The Hyatt Regency has 10 accessible parking spaces in their self-park garage. Most of these are van accessible spaces.
- The accessible route from this hotel to the convention center does not cross the light rail tracks. This is the closest hotel to the convention center accessible entrance.

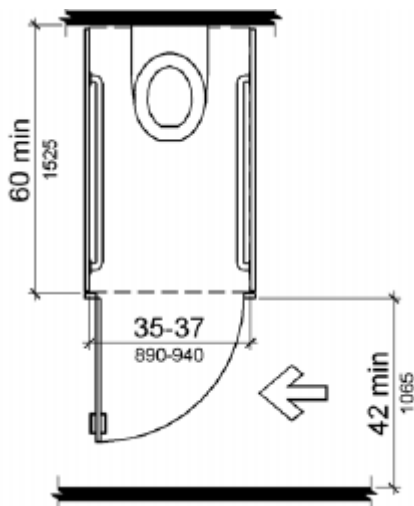
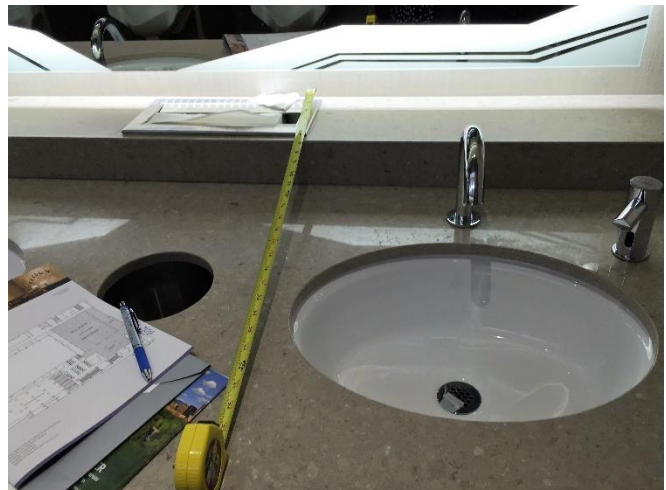
- Paper towel dispensers are too deep in the counter. Recommend placing a towel dispenser on counters behind trash hole. 25" maximum from front edge of counter.

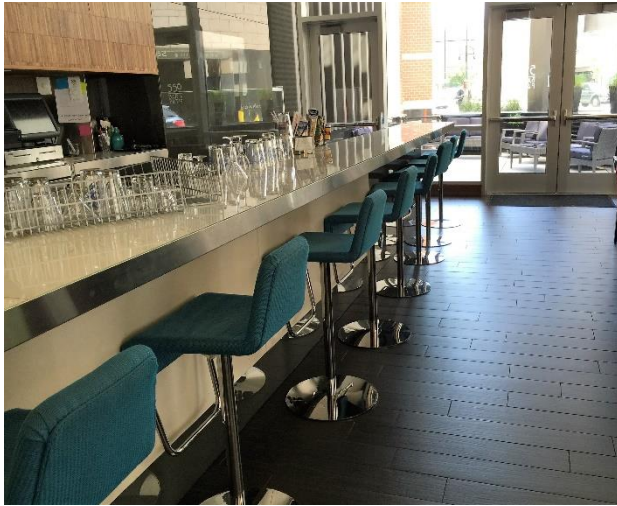
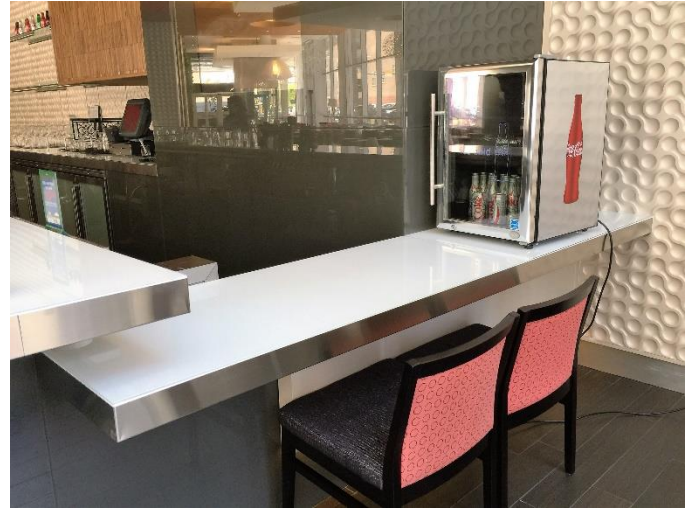
- There is an accessible section at the end of the bar in the dining space.

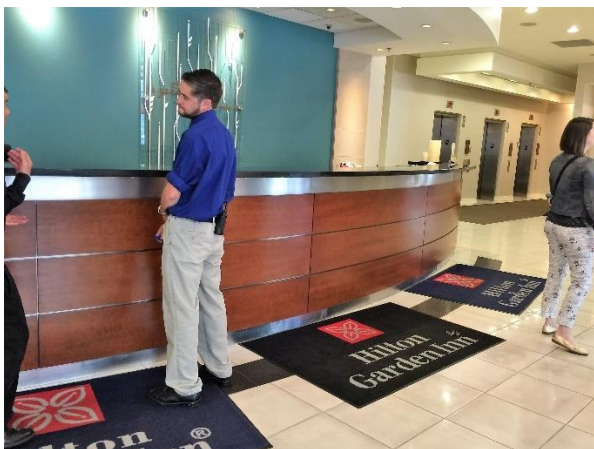
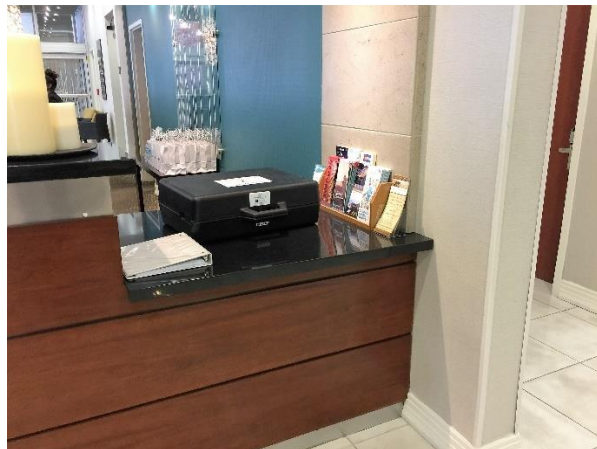
- There is an accessible registration counter at the far end of the counter, not visible from entrance.
